**Location:**  
University Woods  
Fairborn, OH

**Photo Taken by:**  
Matthew Klein, P.E.

**Date:**  
April 11, 2010

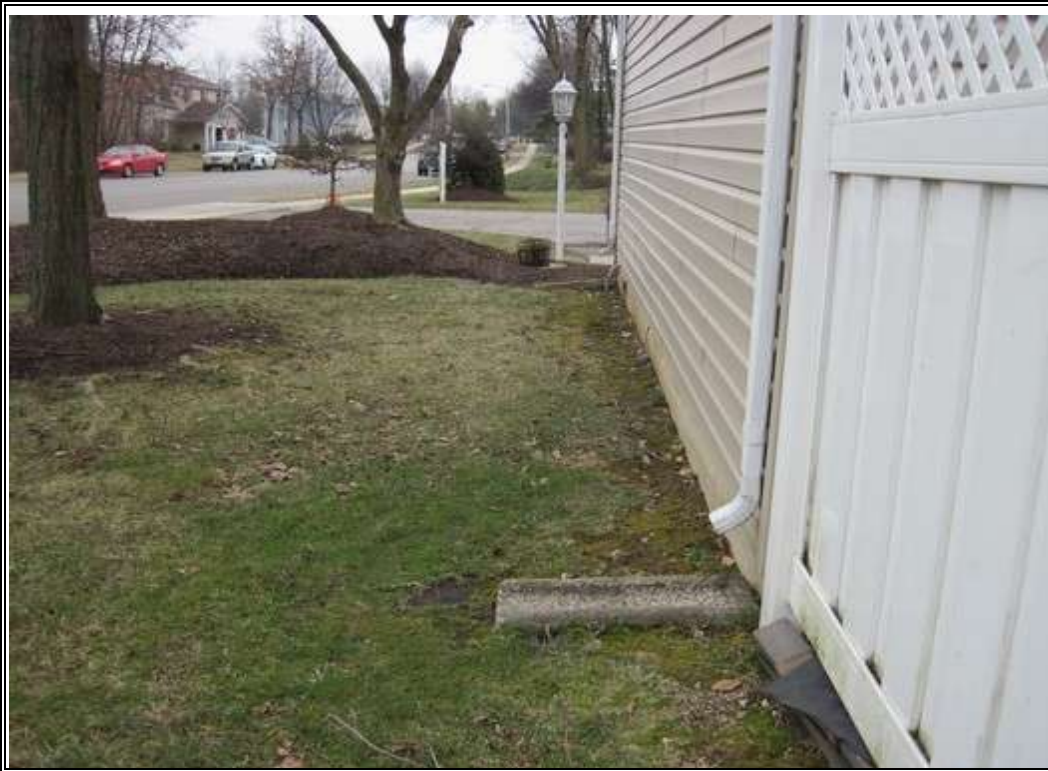
**1**

Downspouts emptying next to the foundation of one of the buildings, which was also typical for most of the buildings. Note the moss growth along the foundation, indicating that the ground stays wet for long periods.

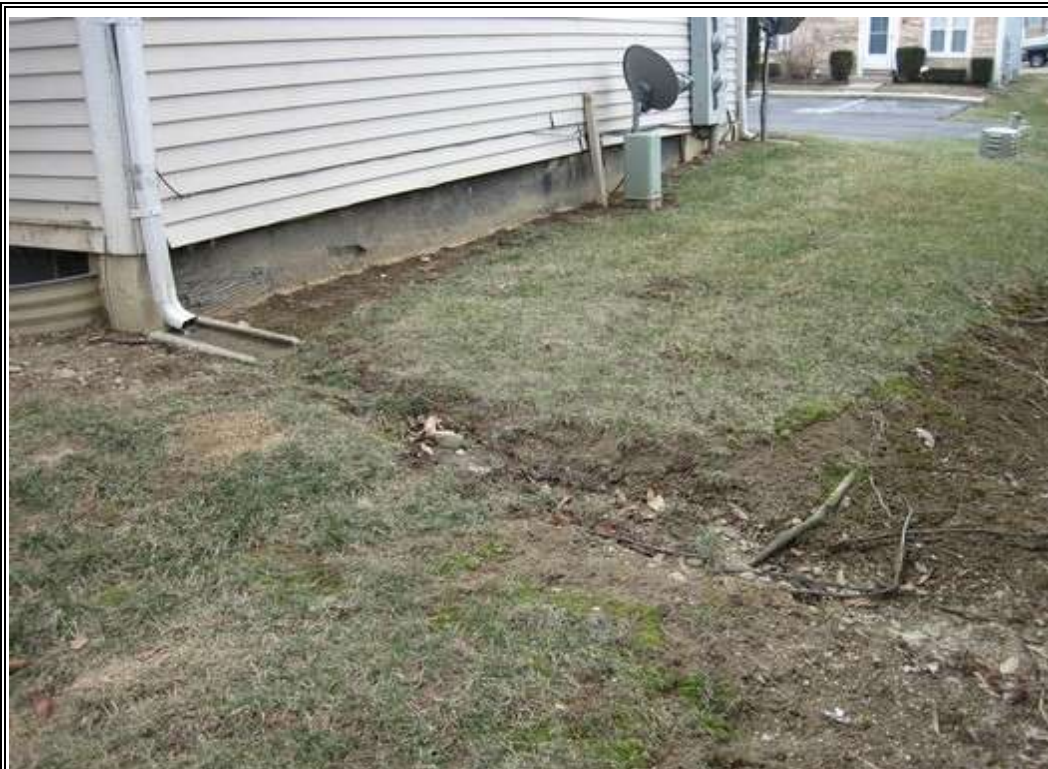
**2**

The downspout outlet of another building, showing extensive soil erosion. Over time, this erosion could undermine the foundation, causing structural problems.

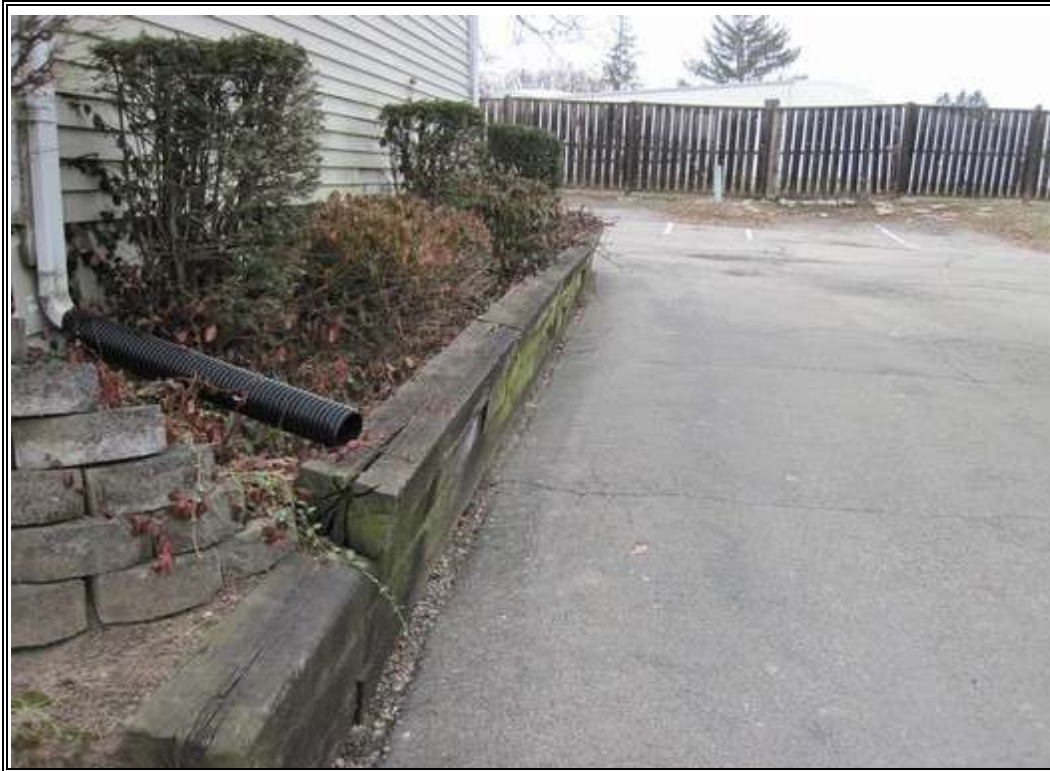
**3**

One of the railroad tie retaining walls that is leaning and in the process of failing. Photo also shows downspout emptying onto the driveway, which could shorten the life of the asphalt and cause winter hazards.

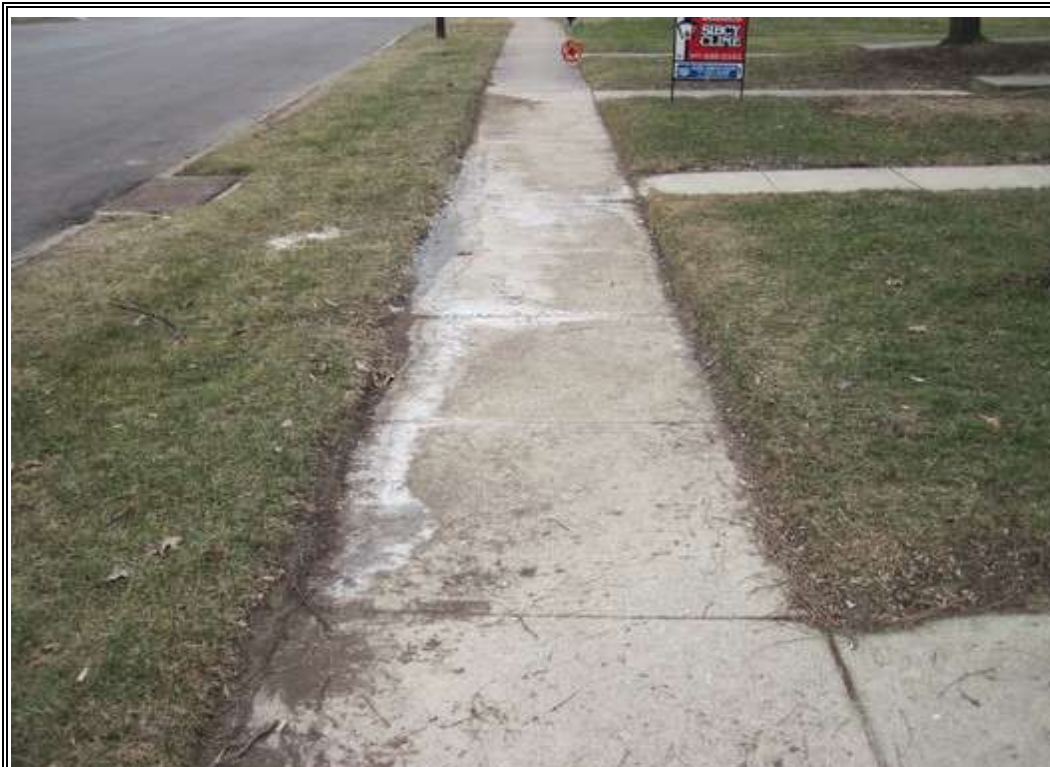
**4**

Water stains on sidewalk showing where water has drained and ponded. Sidewalk appears to have settled due to the excess water. Ponding water can also create a winter hazard.

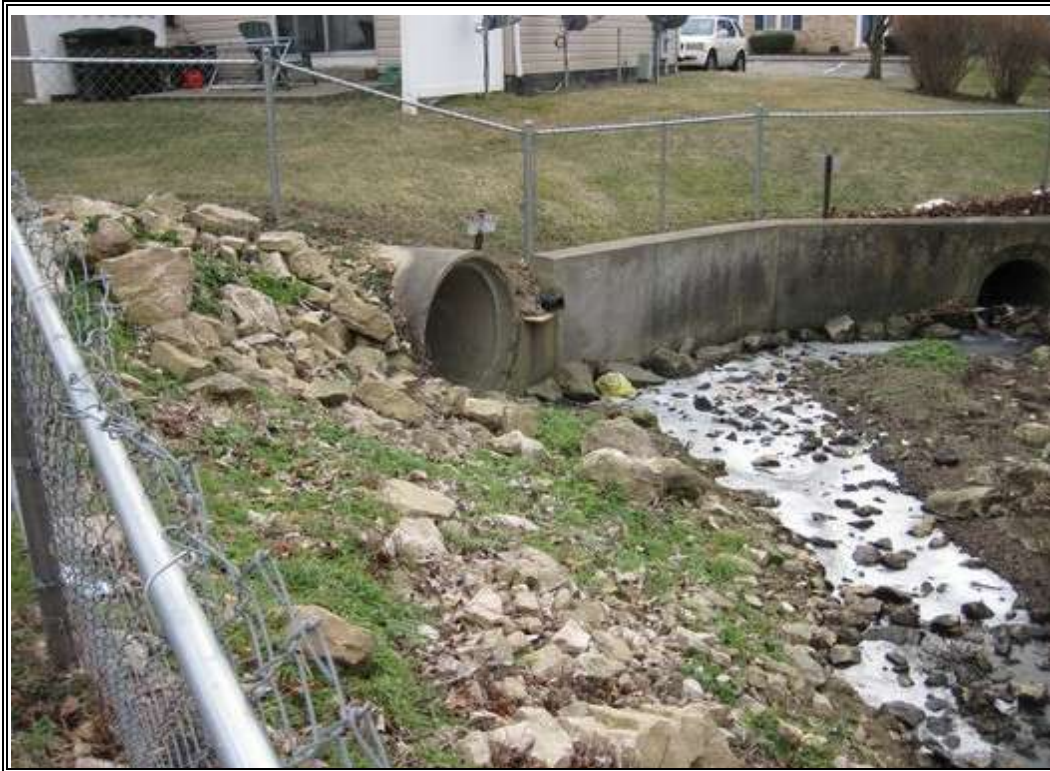
**5**

The community detention pond—this pond has limited storage capacity and this limitation might be related to water getting into the basements of the nearby building.

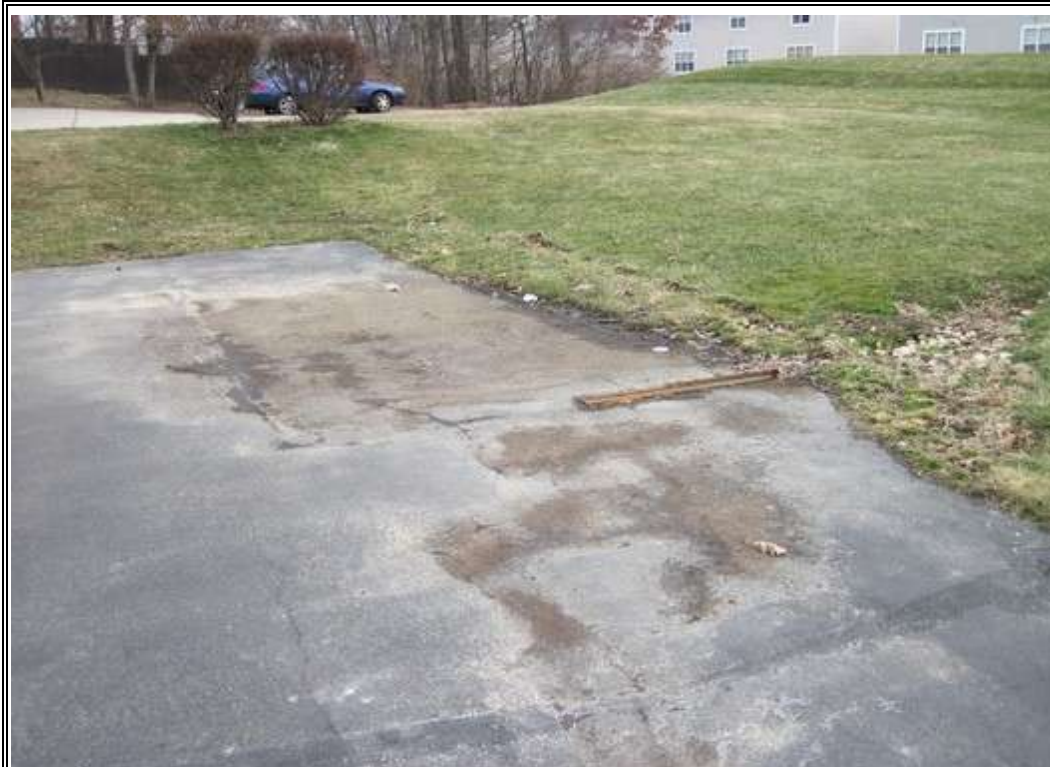
**6**

Example of an area where improper grading has directed water onto an asphalt parking area where the water ponded. Water ponding has likely contributed to deterioration of the asphalt.

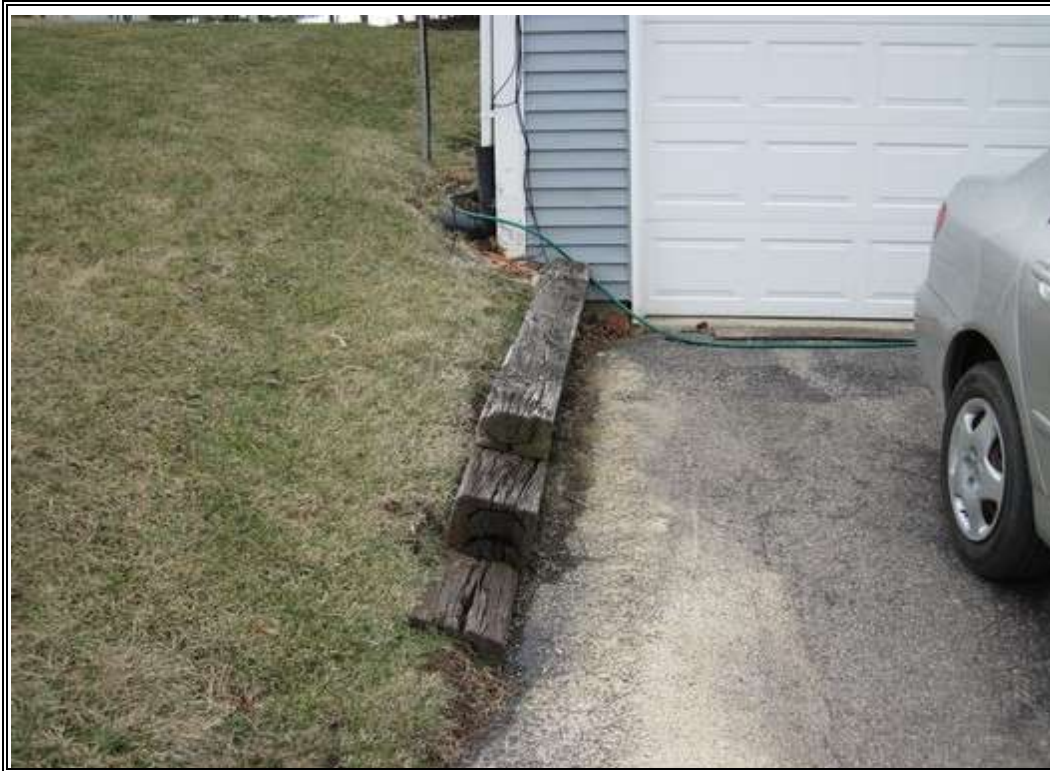
**7**

Improper grading which has directed water toward the building and the retaining wall. Water has likely contributed to failure of the retaining wall and could lead to soil erosion around the foundation.

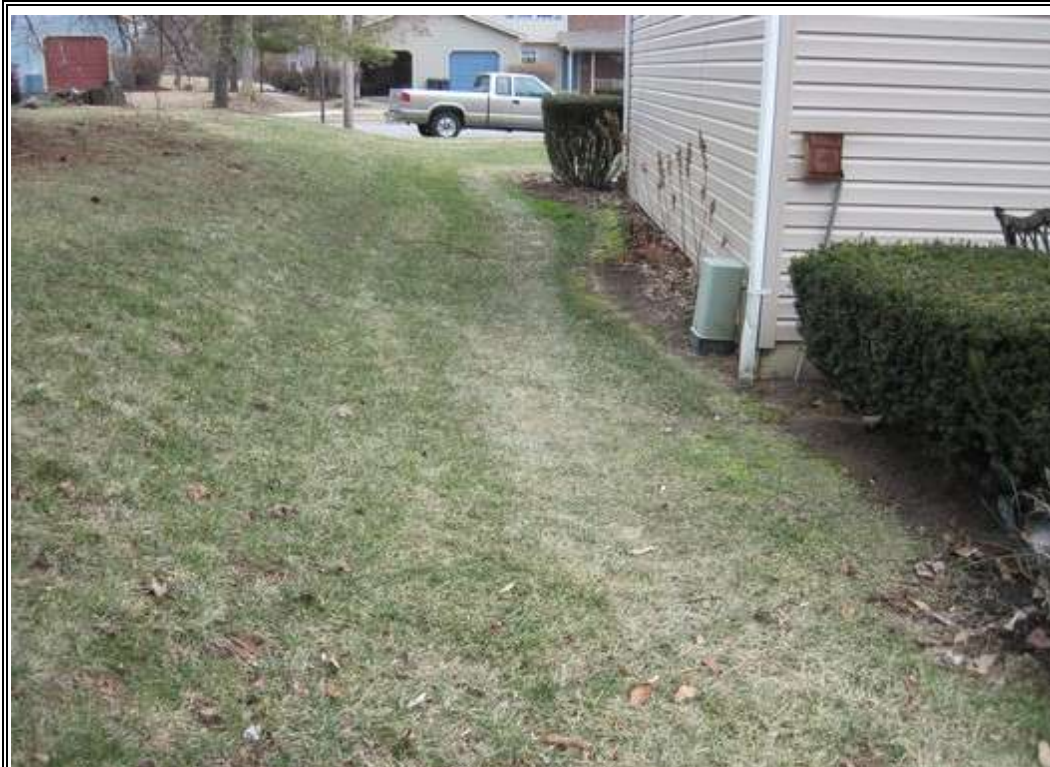
**8**

Another example of improper grading which directs water toward one of the building's foundation. A swell or French drain should have been installed between the buildings to divert the water.

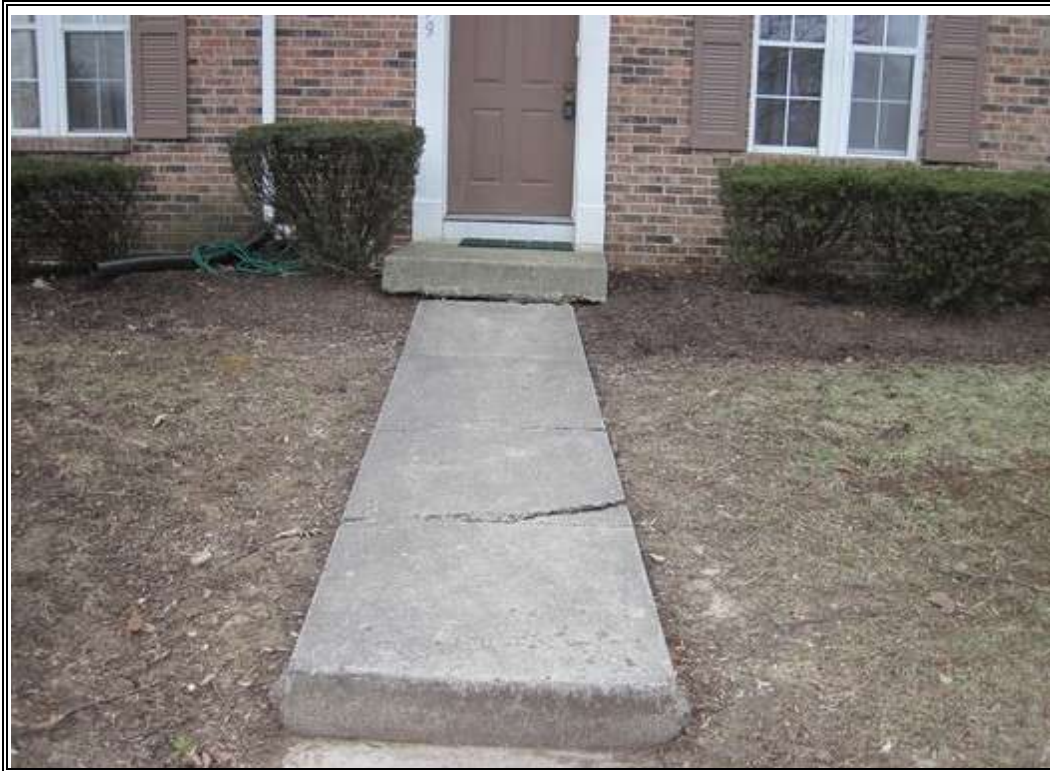
**9**

An example of soil settlement causing settlement and cracking of a sidewalk and increased step height from the stoop. Both of these issues can be trip hazards. Note that downspout drains onto ground next to sidewalk.

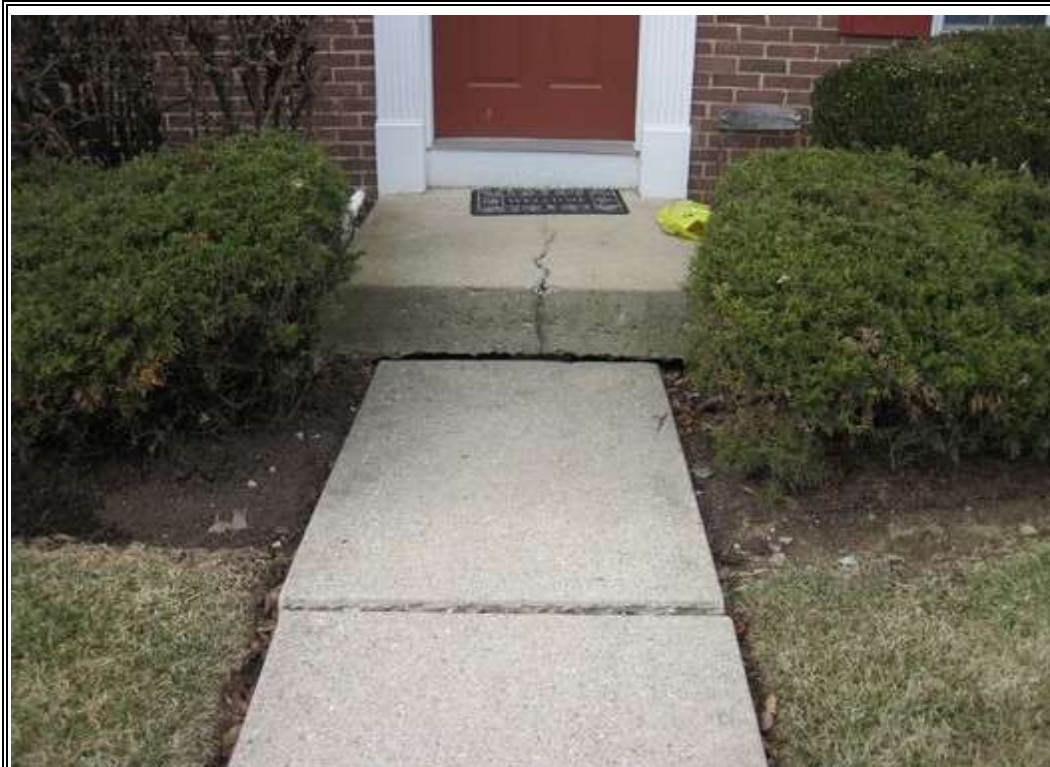
**10**

Another example of sidewalk settlement leading to potential trip hazards. Also shown is crack in stoop concrete caused by single foundation wall installed under the midpoint of the stoop.

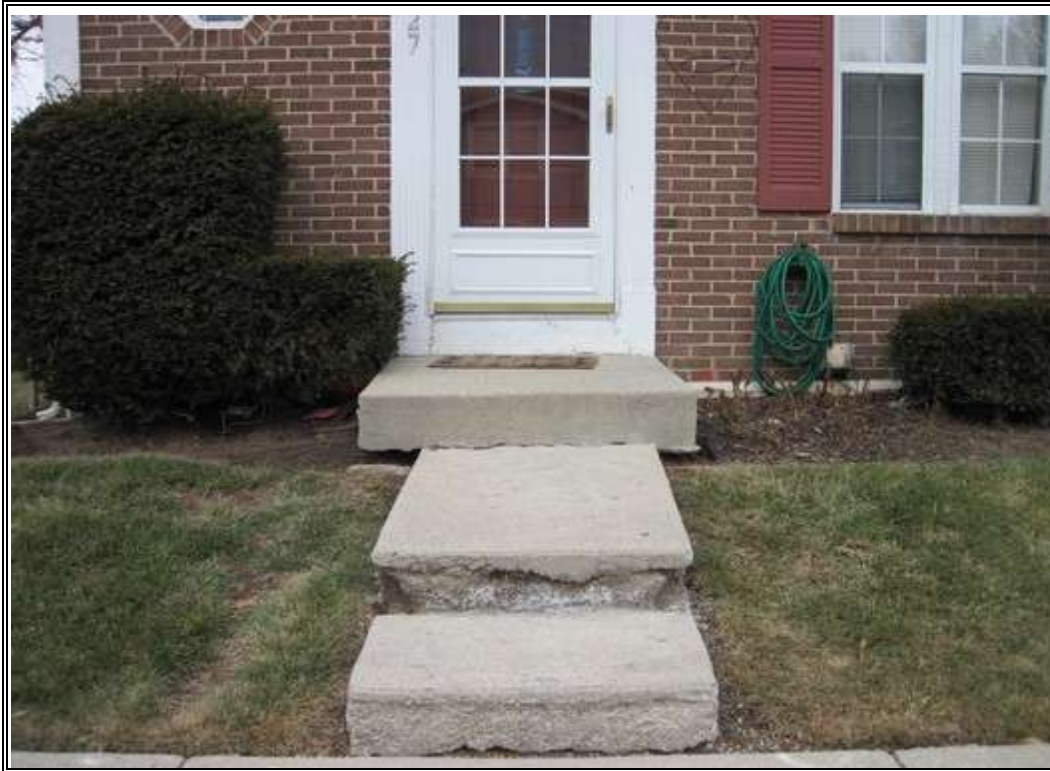
**11**

Deteriorated concrete that will need replacement. This degradation is likely due to poor concrete or installation.

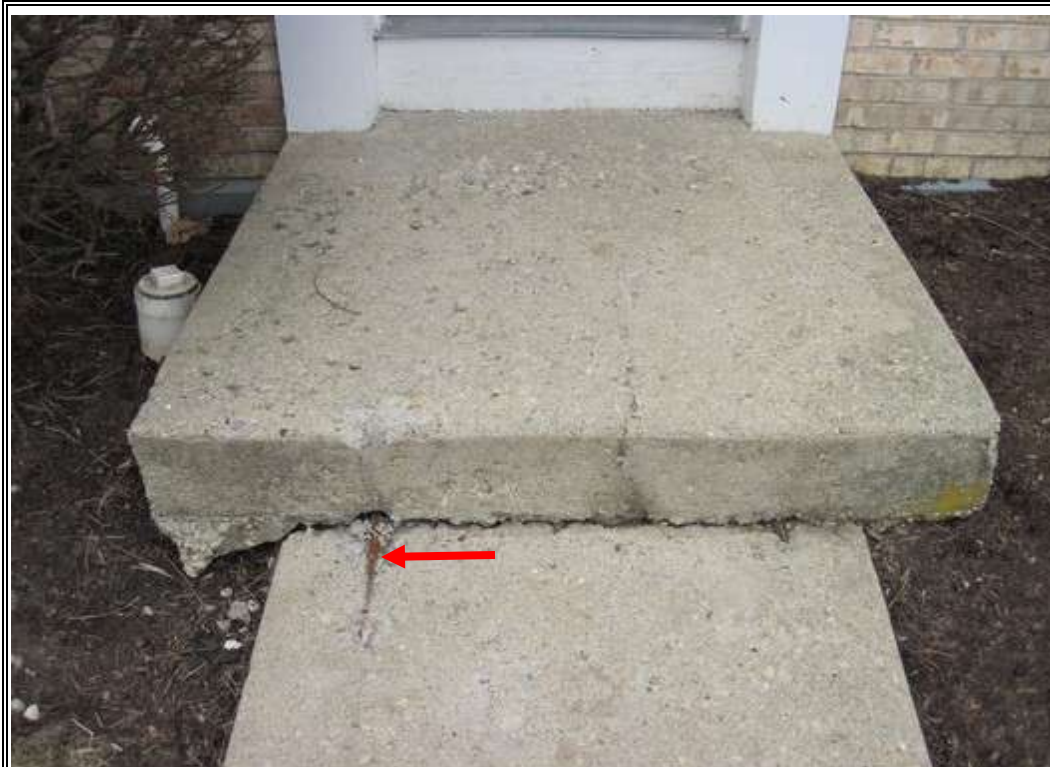
**12**

Rebar sticking up out of concrete. This issue is due to improper rebar installation. Rebar will continue to rust and will cause concrete to degrade. Also note crack in stoop concrete due to single foundation wall under middle of stoop.

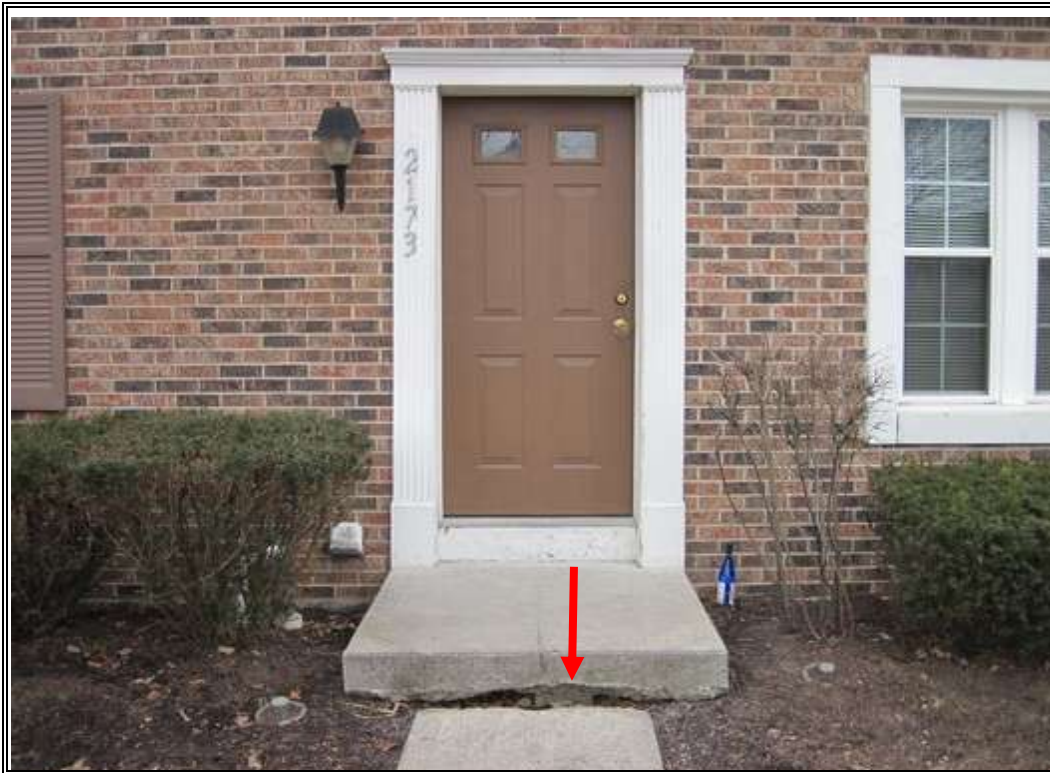
**Photo Number**  
**13**

Demonstration of where a single foundation wall, revealed by sidewalk settlement, has led to a crack in the stoop.

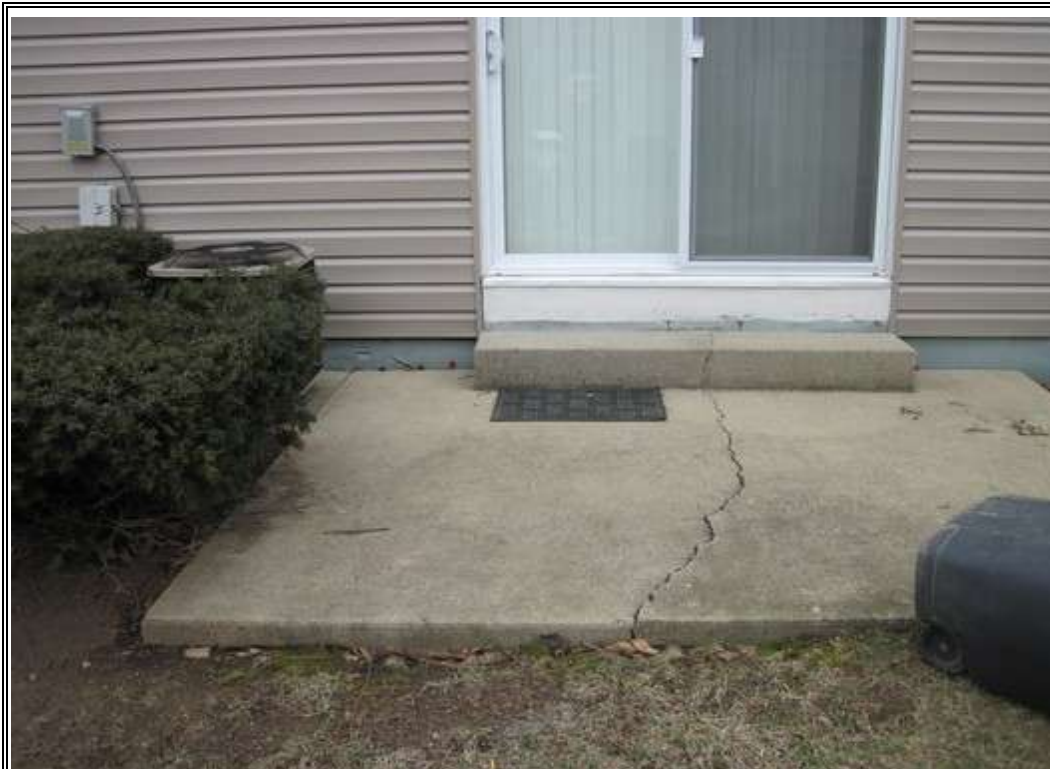
**Photo Number**  
**14**

An example of cracks and heaving of a patio due apparently to settlement. A number of patios had cracks in a similar location.

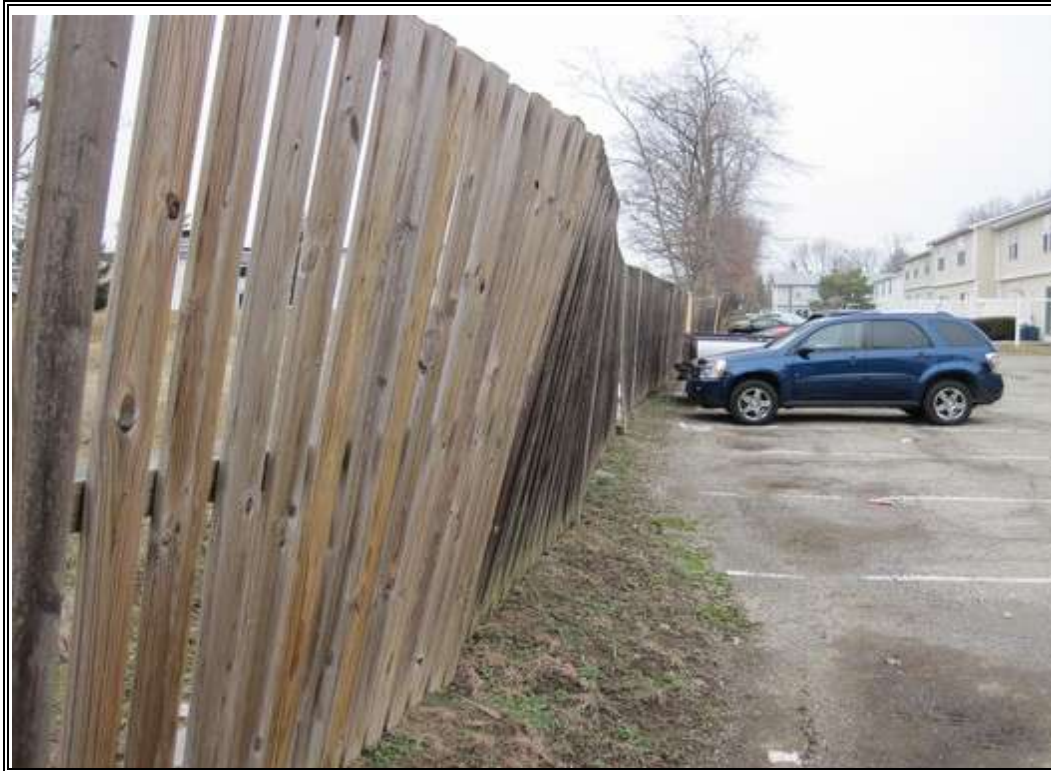
**15**

Example of the privacy fence along the boundary of the Association property leaning. This leaning could be due to the fence posts not being deep enough into the soil for the fence height and soil conditions.

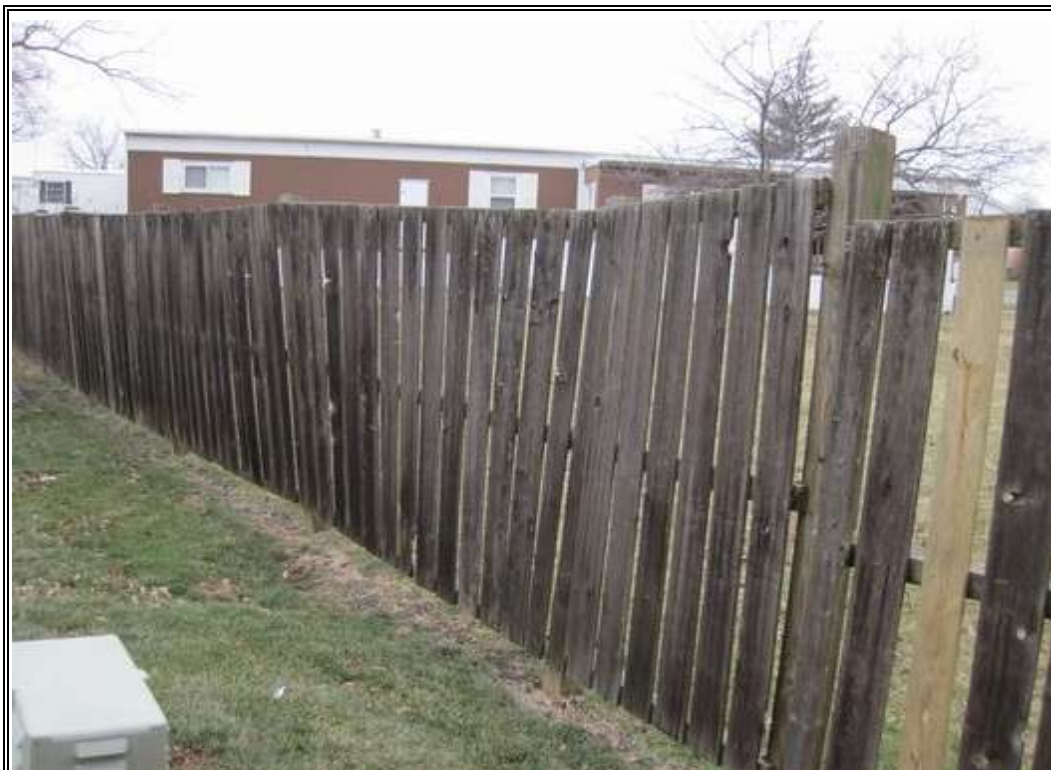
**16**

One part of the privacy fence installed along the edge of a drainage ditch. Saturation of the soil can weaken the fence anchorage in the soil.

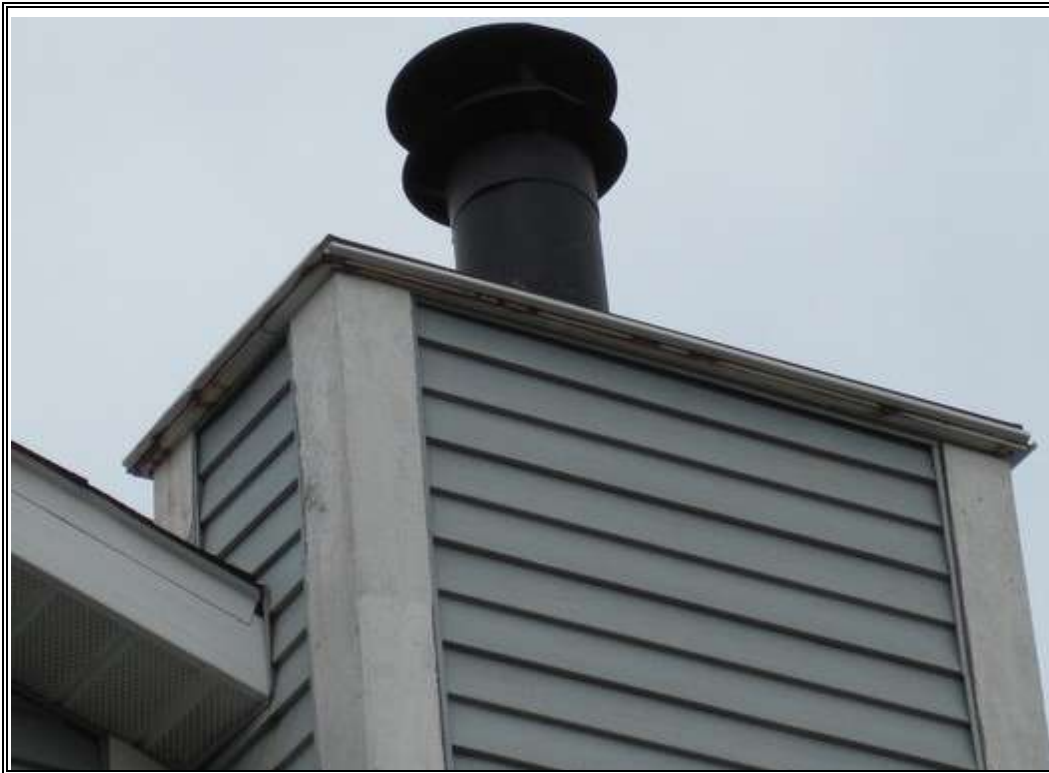
**17**

Rust around one building's chimney cap. Rust was also seen on other chimney caps. Also note that roof is pitched into the siding on the chimney without proper flashing to divert the rainwater.

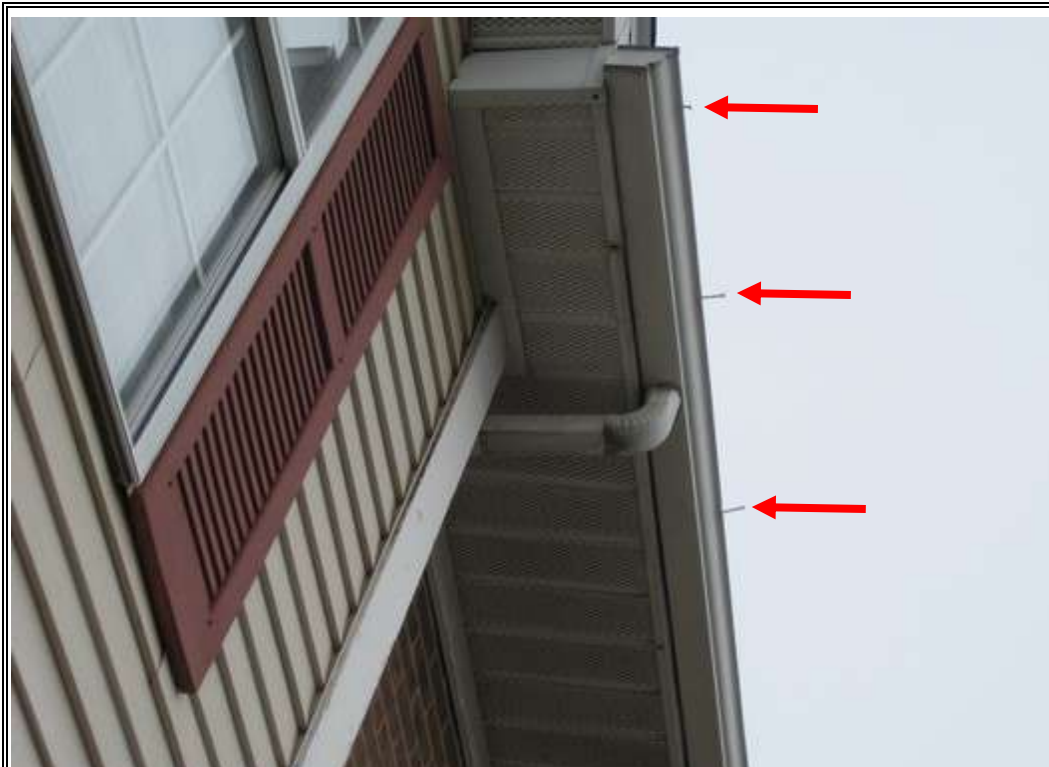
**18**

Gutter nail pops which could indicate possible fascia problems, such as wood rot.

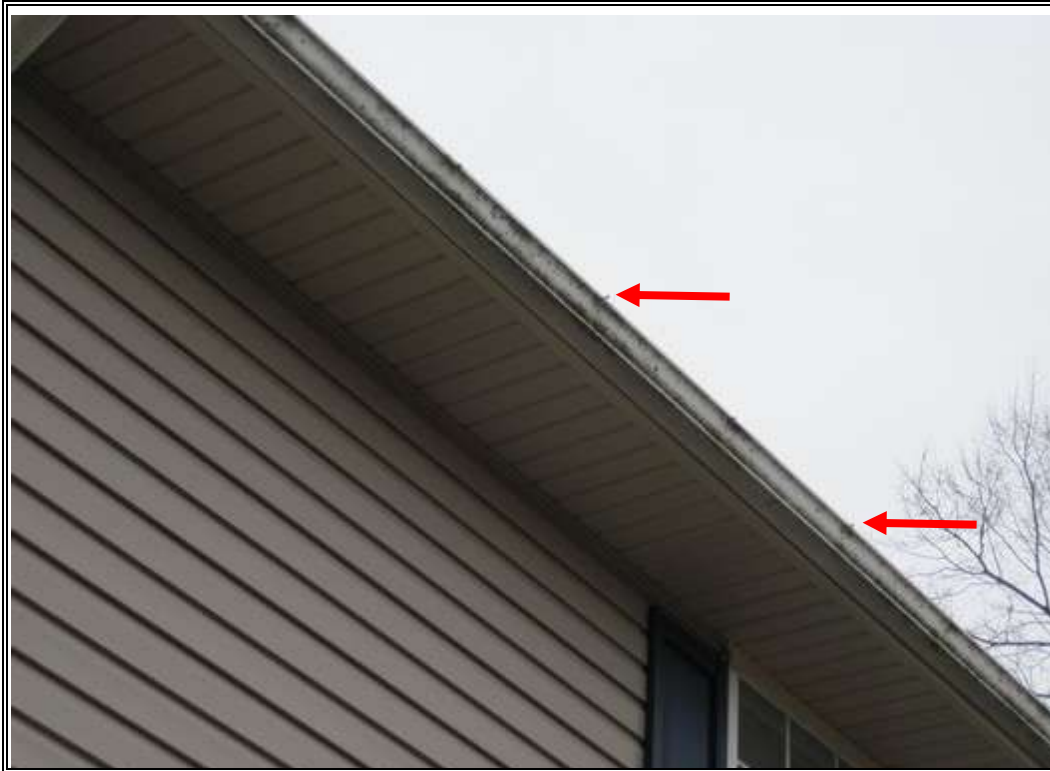
**Photo Number**  
**19**

Gutter nail pops on another building. Also visible are water stains showing where the gutter has chronically overflowed.

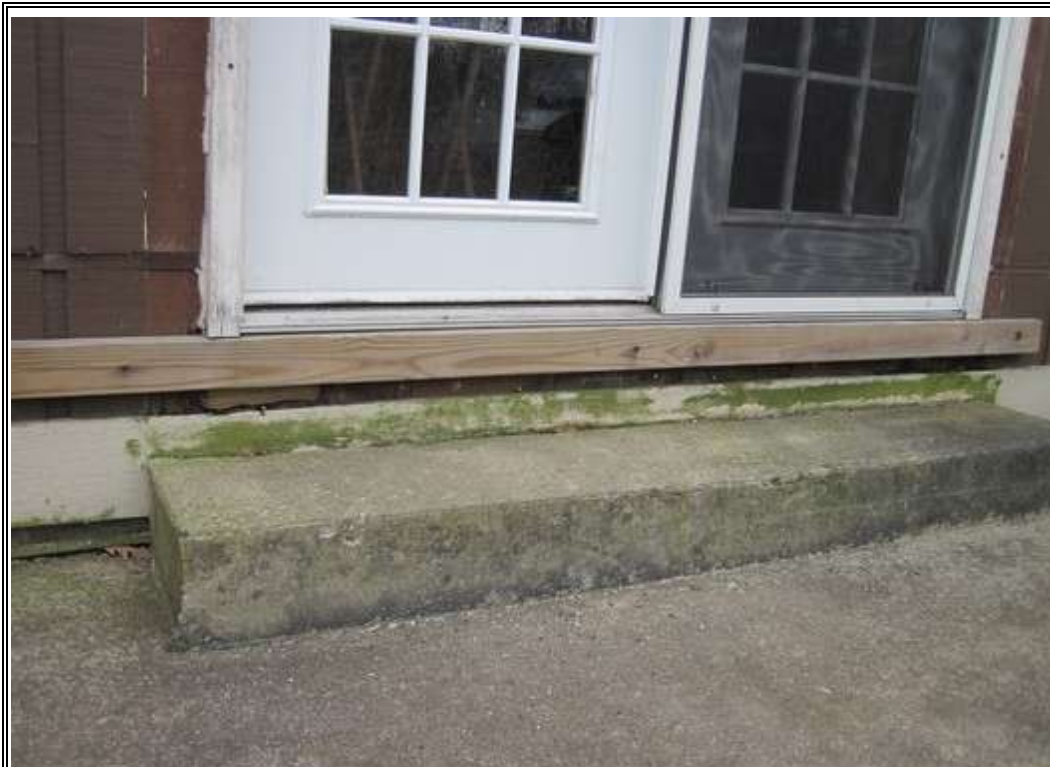
**Photo Number**  
**20**

Example problems due to overflowing gutters. In this case, they are rotting wood and algae growth.

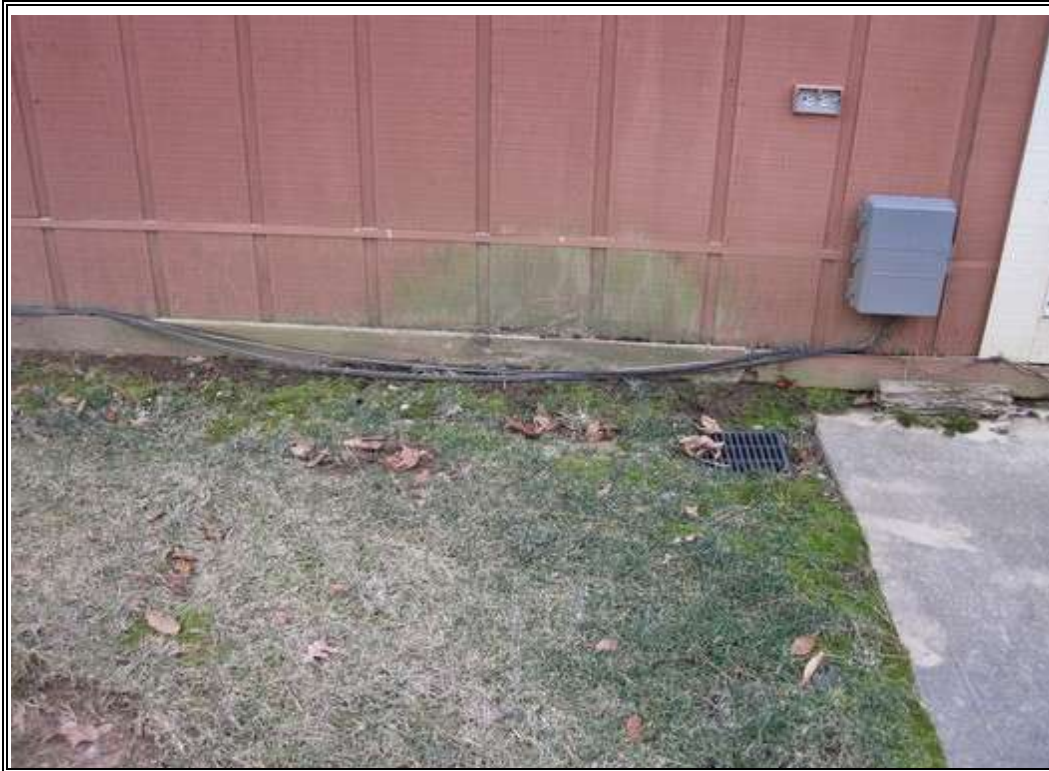
**Photo Number**  
**21**

Example of another area where overflowing gutter has led to algae growth and rotten wood. T1-11 such as that shown in photo is particularly susceptible to water damage.

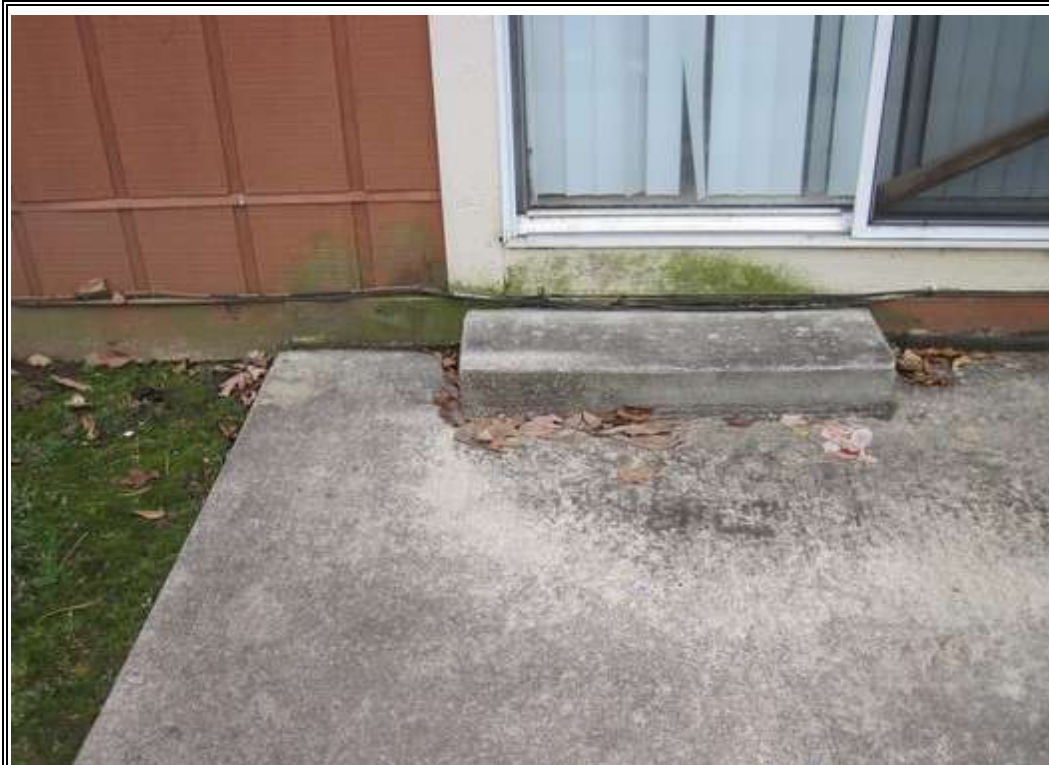
**Photo Number**  
**22**

Another building where overflowing gutters have led to algae growth and wood rot.

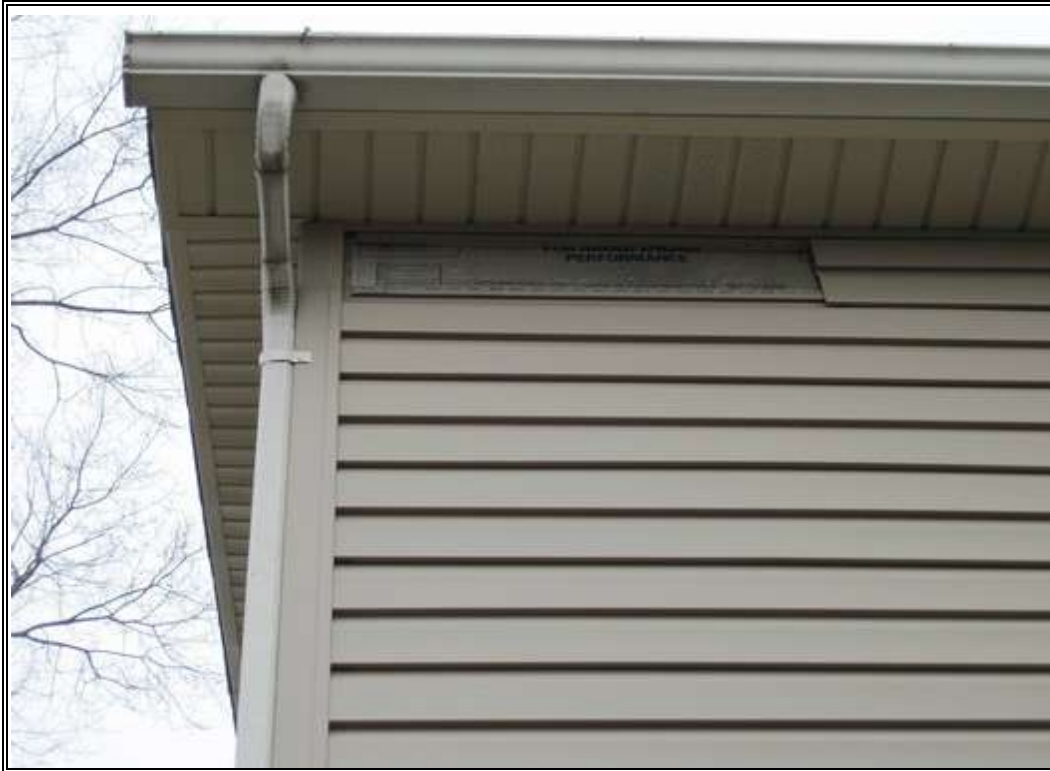
**23**

An example of missing siding. This problem was present but not widespread. Another example of a gutter nail pop is shown in this photo.

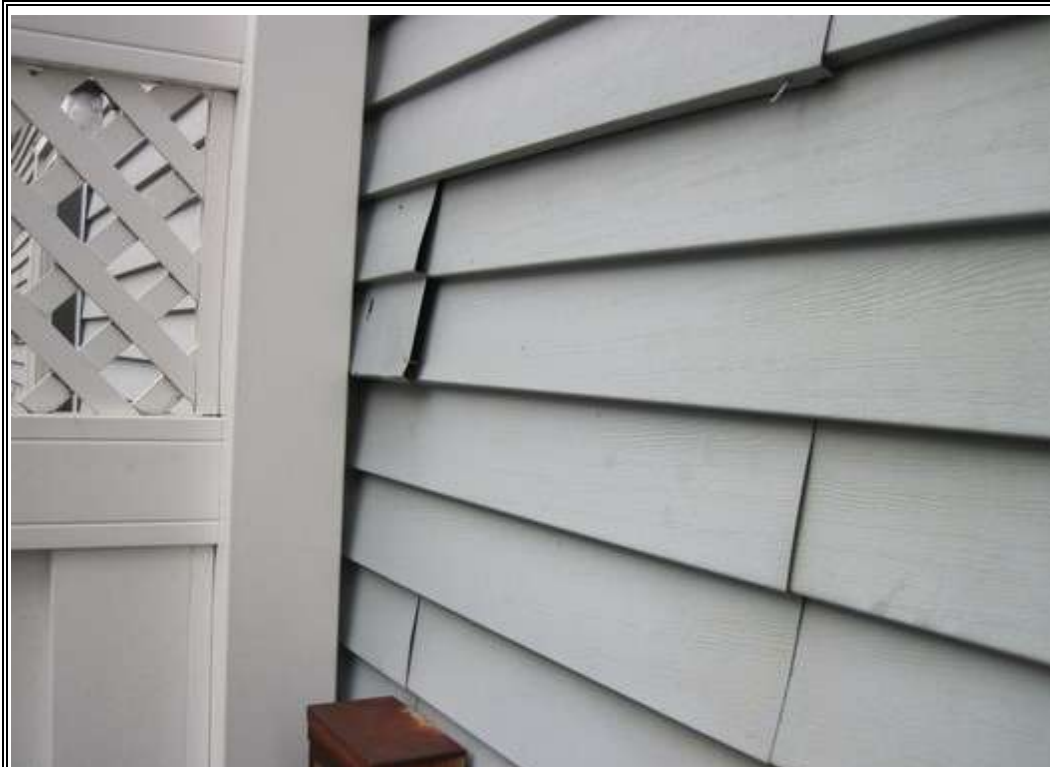
**24**

An example of loose siding that needs repair. Gaps opened by loose siding can allow water behind the siding that can cause damage and leaves edges where wind can rip the siding off.

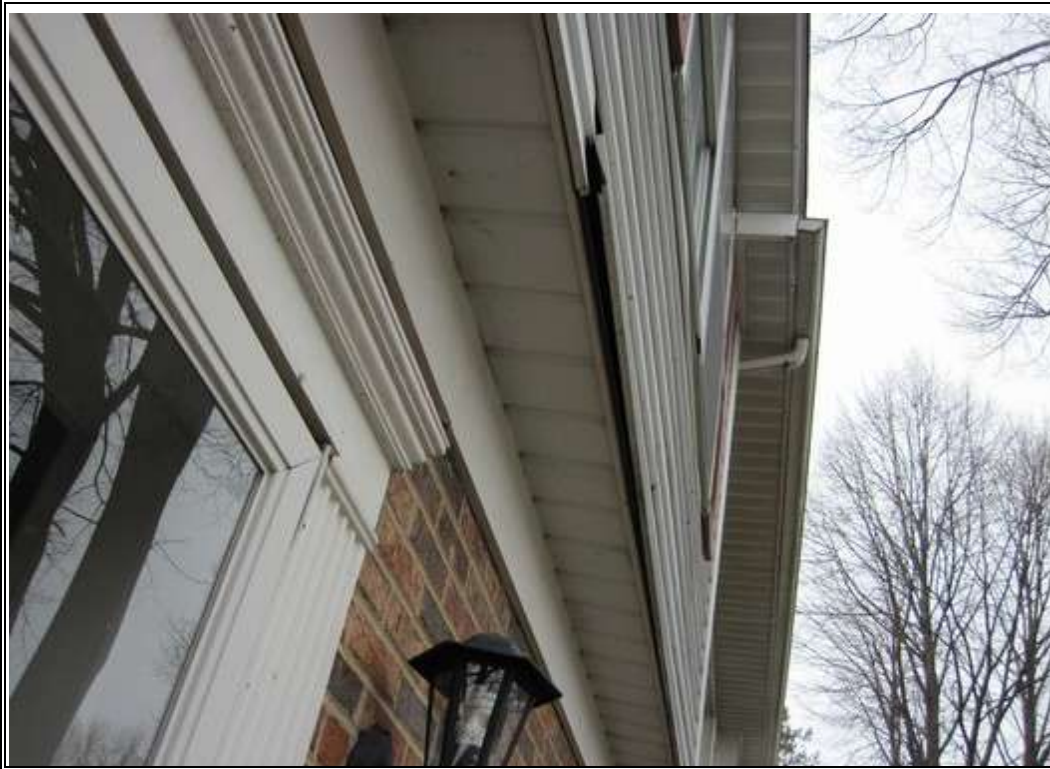
**Photo Number**  
**25**

Another example of loose siding. A relatively large number of loose siding problems were found in the community. This problem is one that needs Association attention.

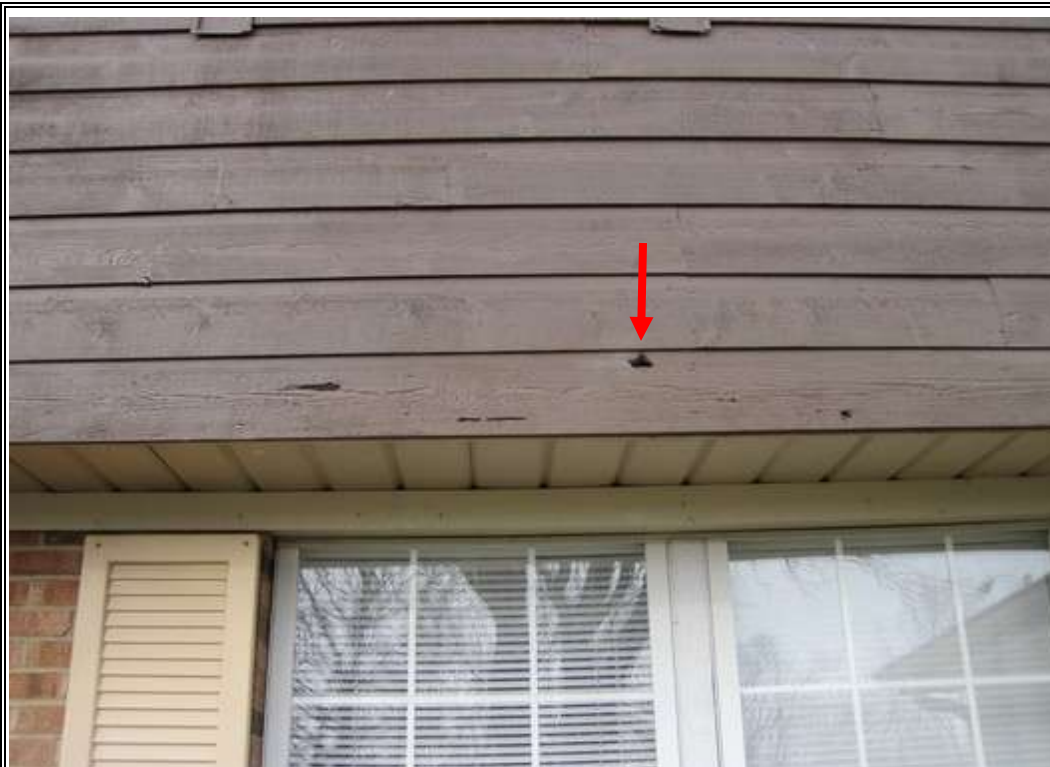
**Photo Number**  
**26**

A hole in the cedar siding where pests or moisture can enter behind the siding. These holes should be repaired as rapidly as possible.

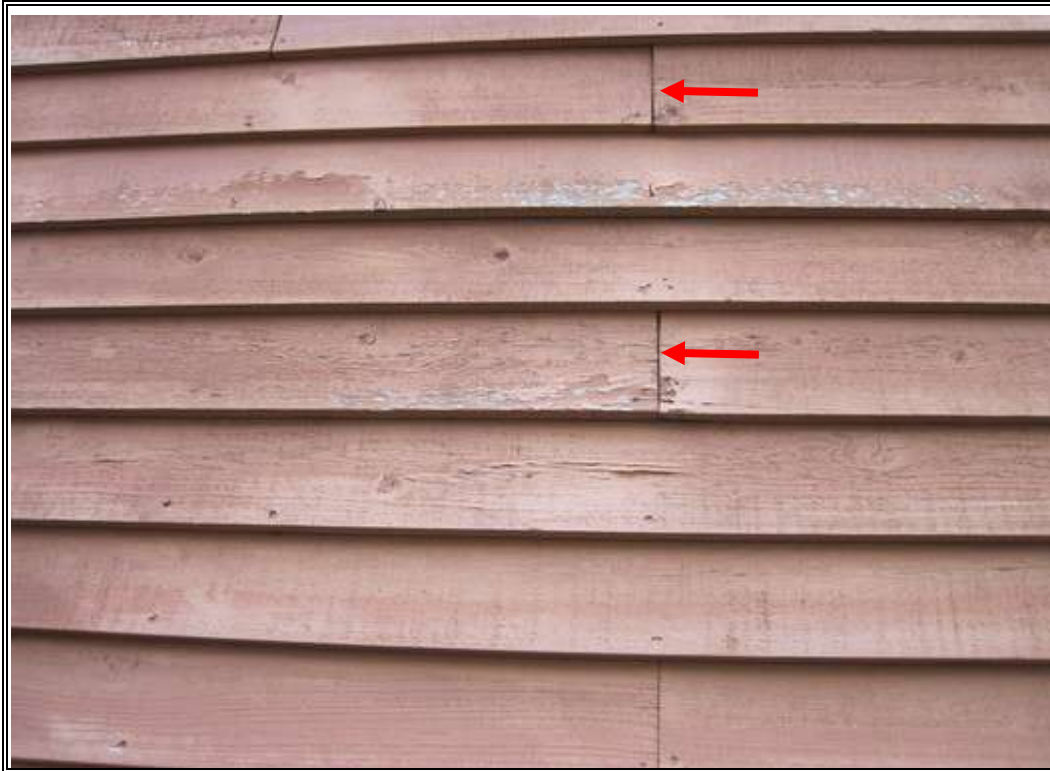
**27**

Gaps between wood siding boards. These gaps allow moisture to get behind the siding particularly during wind-driven rains. These gaps need to be caulked.
