**Location:**  
University Woods  
Fairborn, OH

**Photo Taken by:**  
Matthew Klein, P.E.

**Date:**  
April 11, 2010

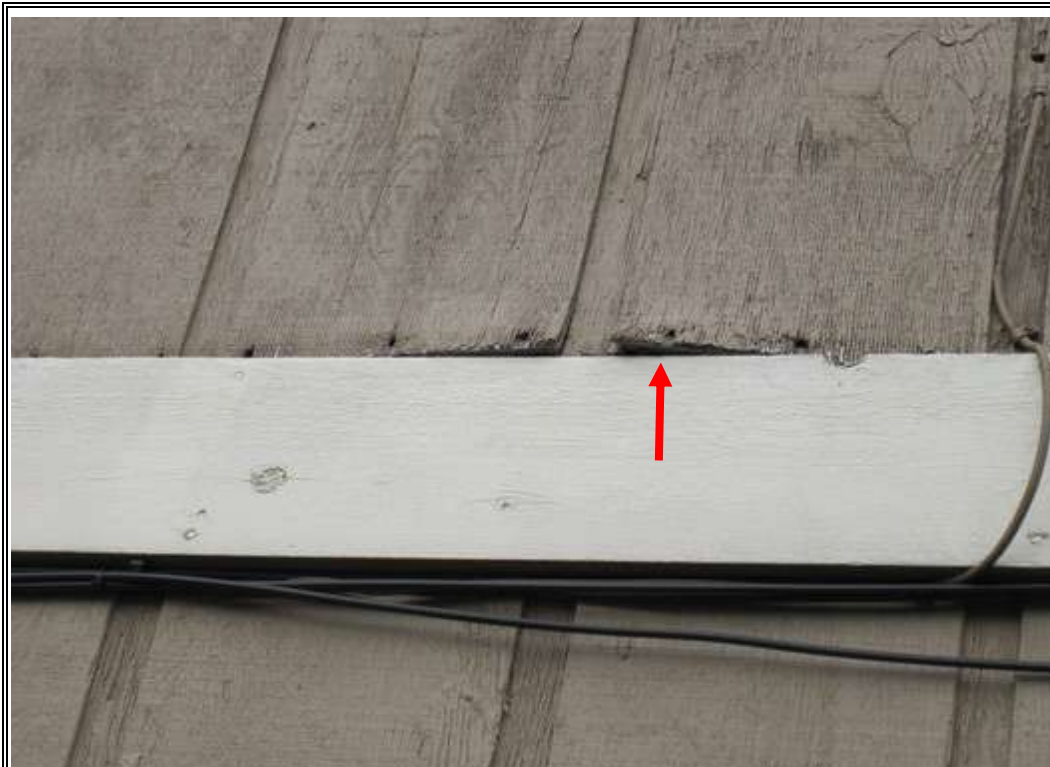
**28**

An example of moisture damage to T1-11 siding, which is particularly susceptible to such damage. Also notable is that flashing should have been installed behind the T1-11 and over the trim board.

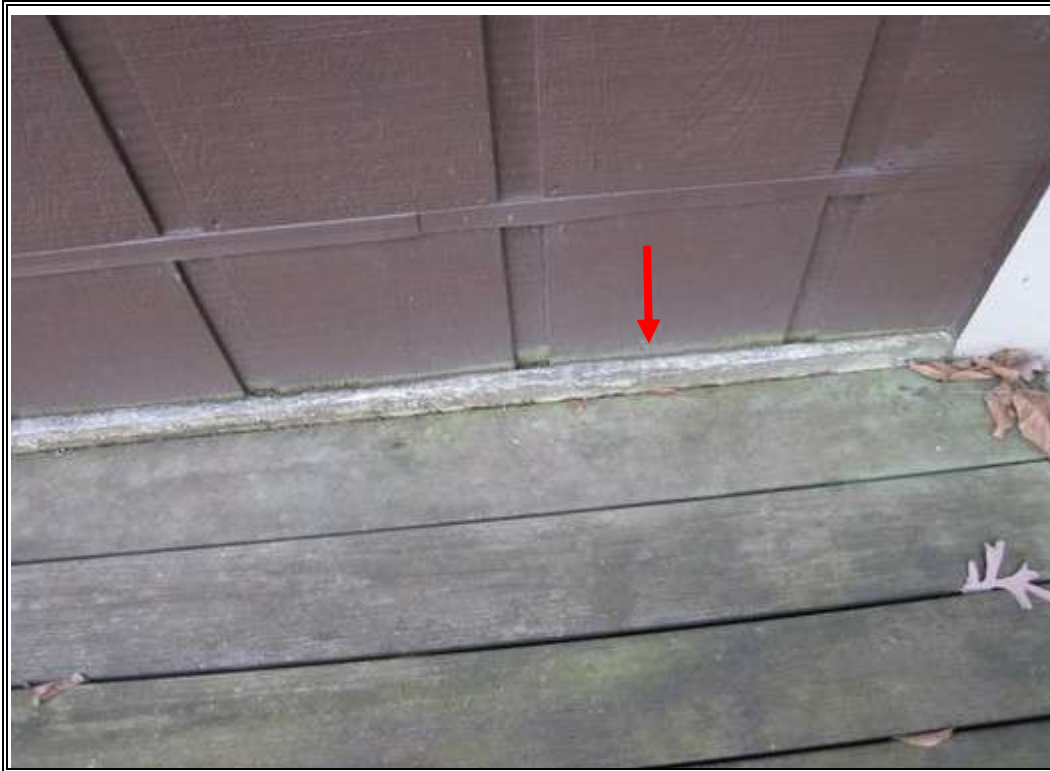
**Photo Number**  
**29**

Another example of moisture damage to T1-11. This damage was widespread for buildings with T1-11.

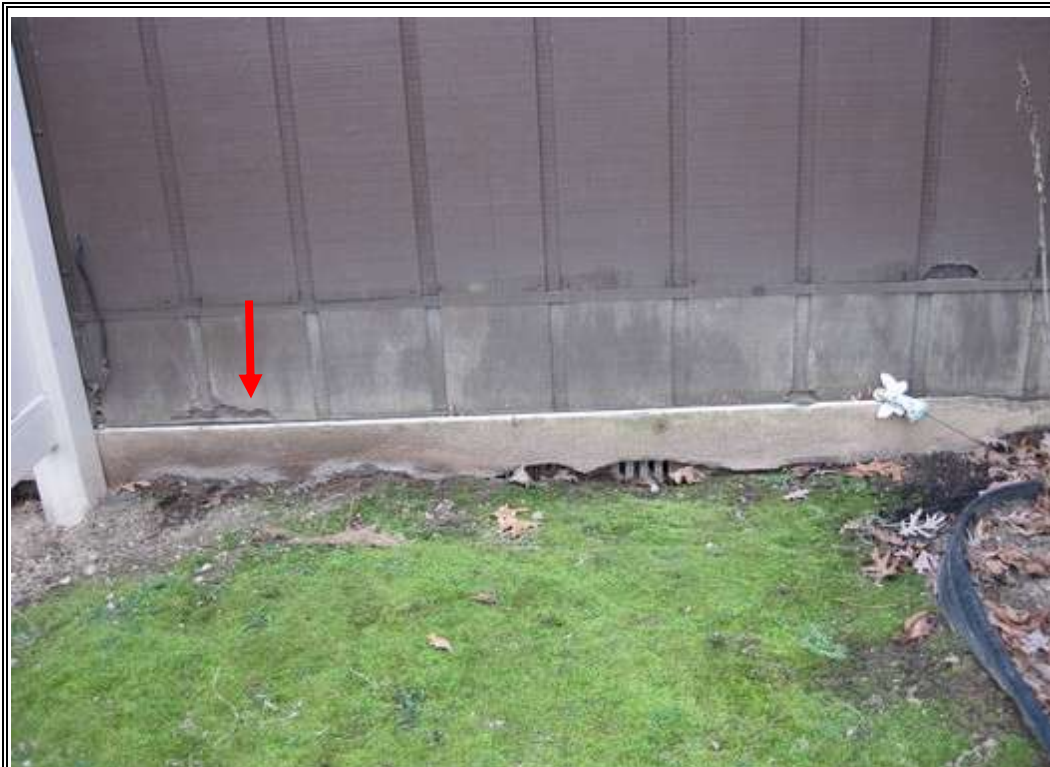
**Photo Number**  
**30**

Moisture damage in another area of T1-11. Moisture in this case has likely splashed onto the siding due to overflowing gutters.

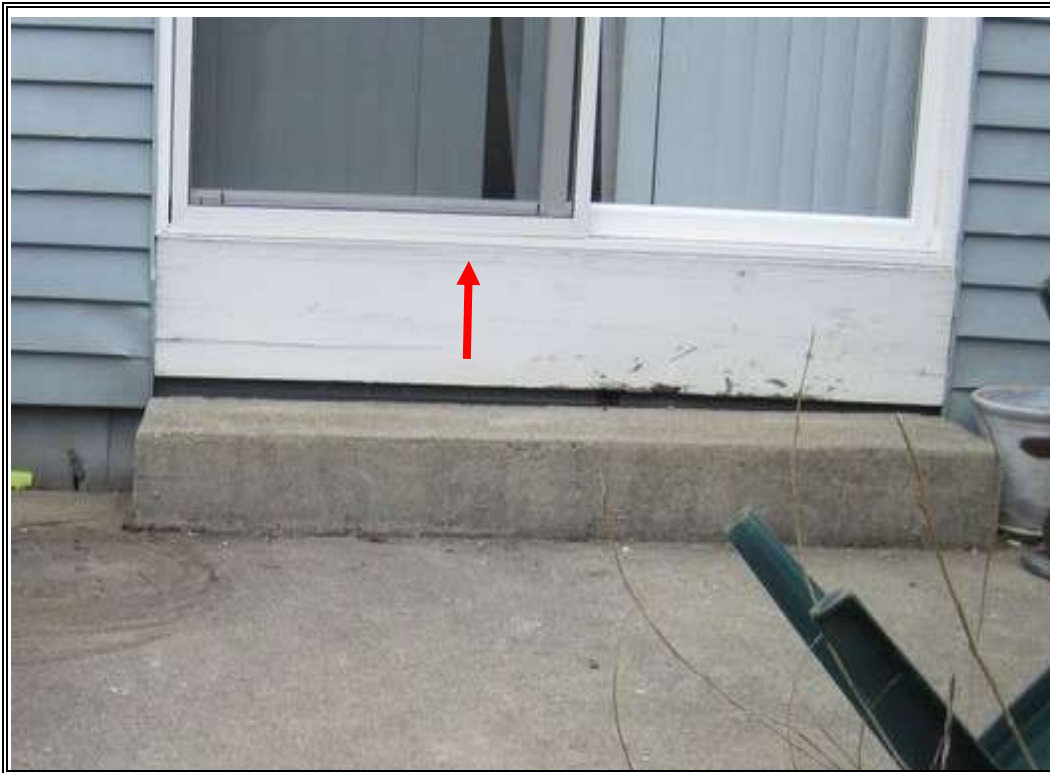
**Photo Number**  
**31**

A location where flashing should have been installed—under the threshold and over the kickboard.

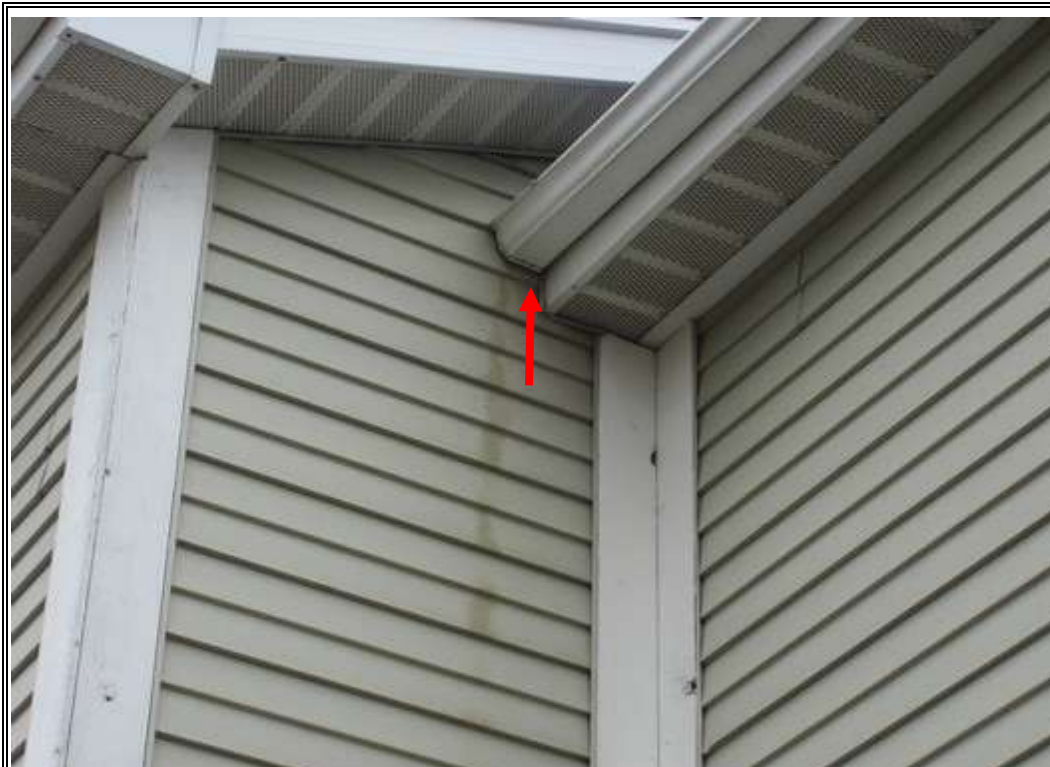
**Photo Number**  
**32**

An example of where kickout flashing should have been installed on the roof to direct water away from the gap between the gutter and wall.

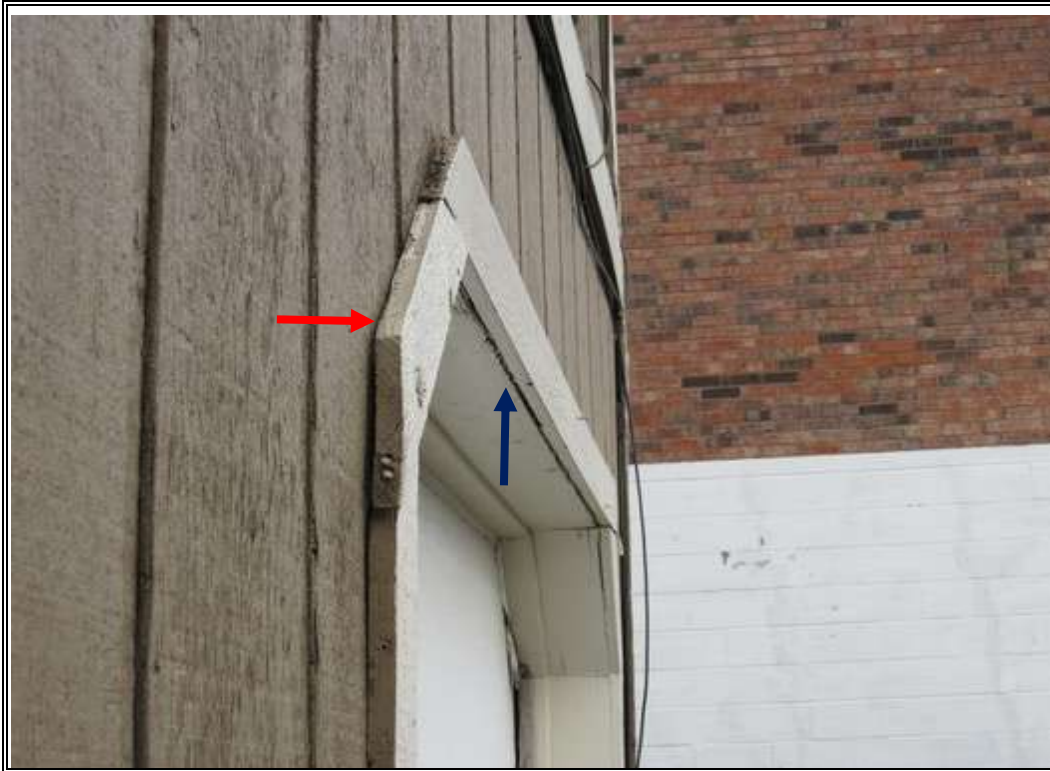
**33**

Warping of molding due to moisture exposure. Flashing should have been installed over the molding. Once molding warps, water can get behind it and cause rot, as shown by blue arrow.

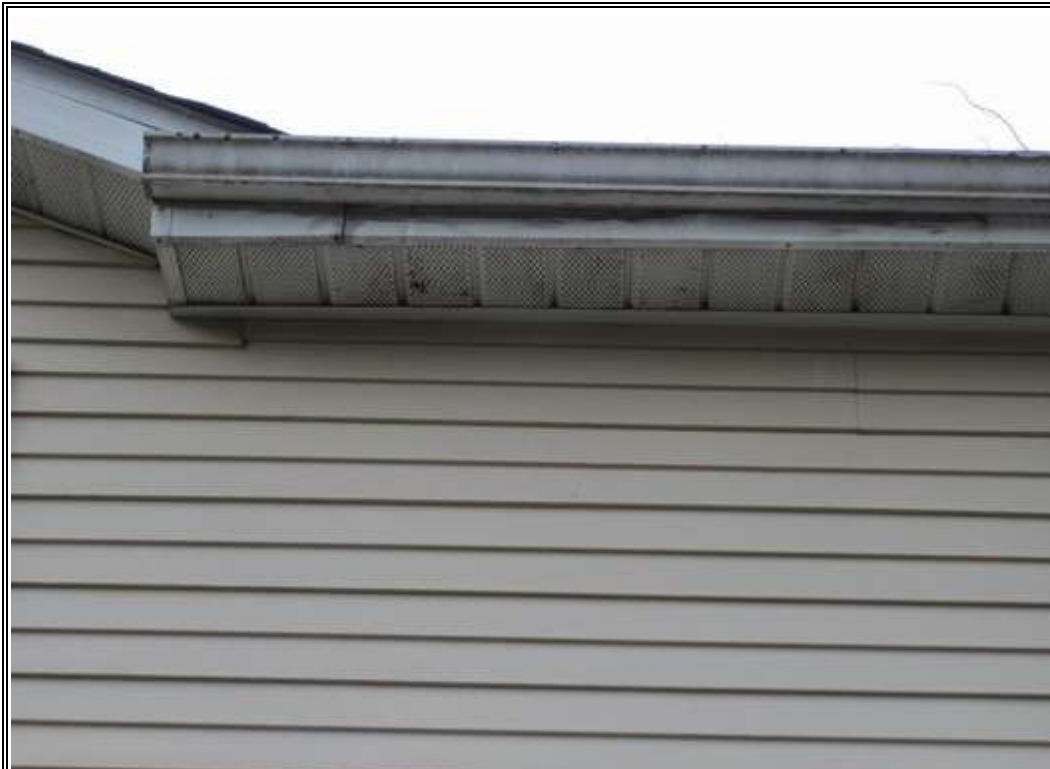
**34**

Water staining under gap between fascia and gutter indicating that water is running through gap rather than into gutter. A drip edge may not have been installed along the roof edge.

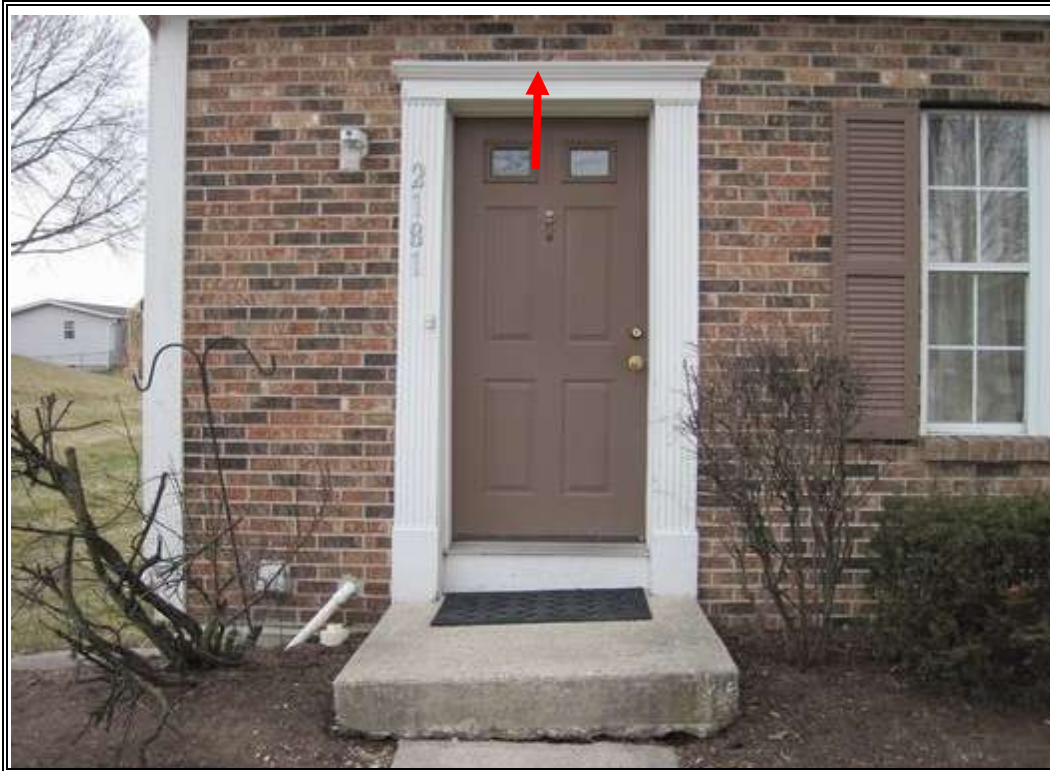
**Photo Number**  
**35**

Flashing should have been installed between the brick and top of the door lintel. None of the doors had this flashing and in several cases, the molding was warped due to the moisture exposure.

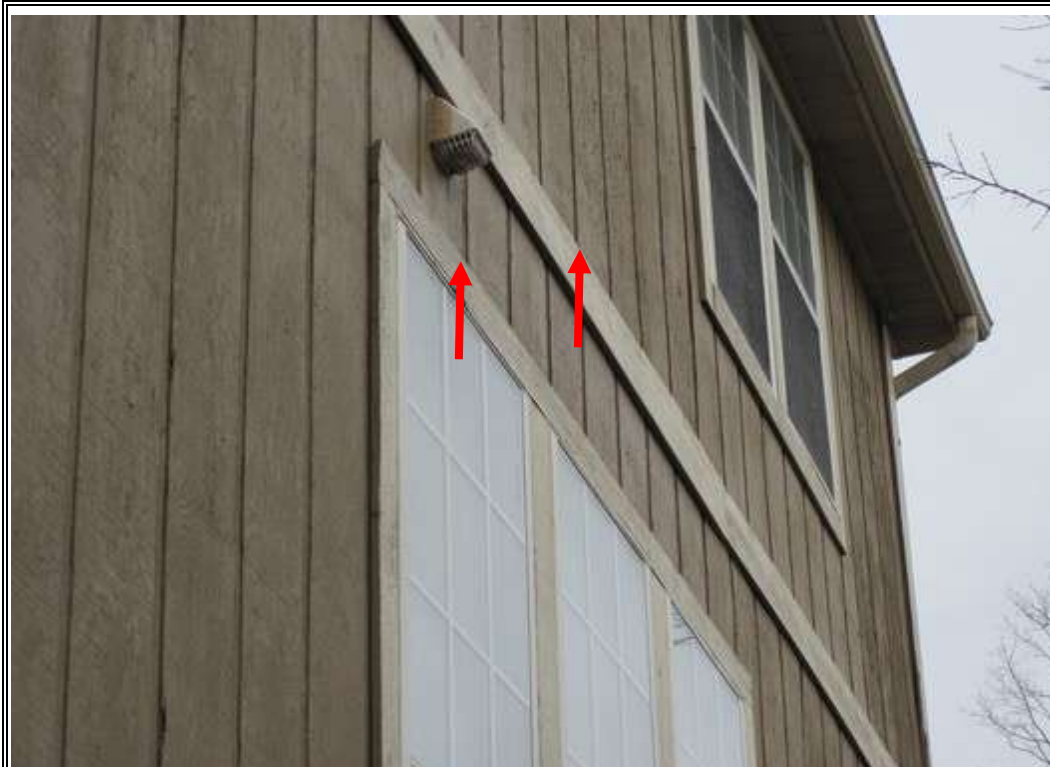
**Photo Number**  
**36**

Two locations where flashing should have been installed—over the window molding and trim board. In this case, moisture has led to the top molding warping.

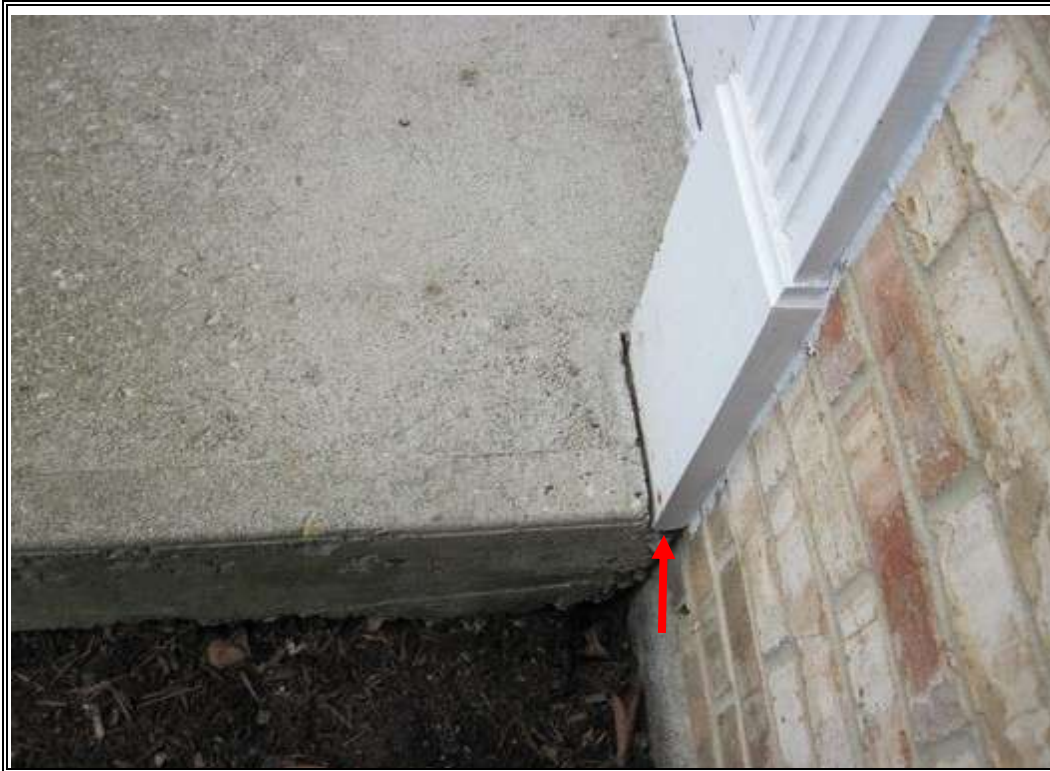
**Photo Number**  
**37**

Door pilaster installed below concrete surface of the stoop, or more likely the stoop was installed after the pilasters were installed. This location is one where water can collect and rot the wood.

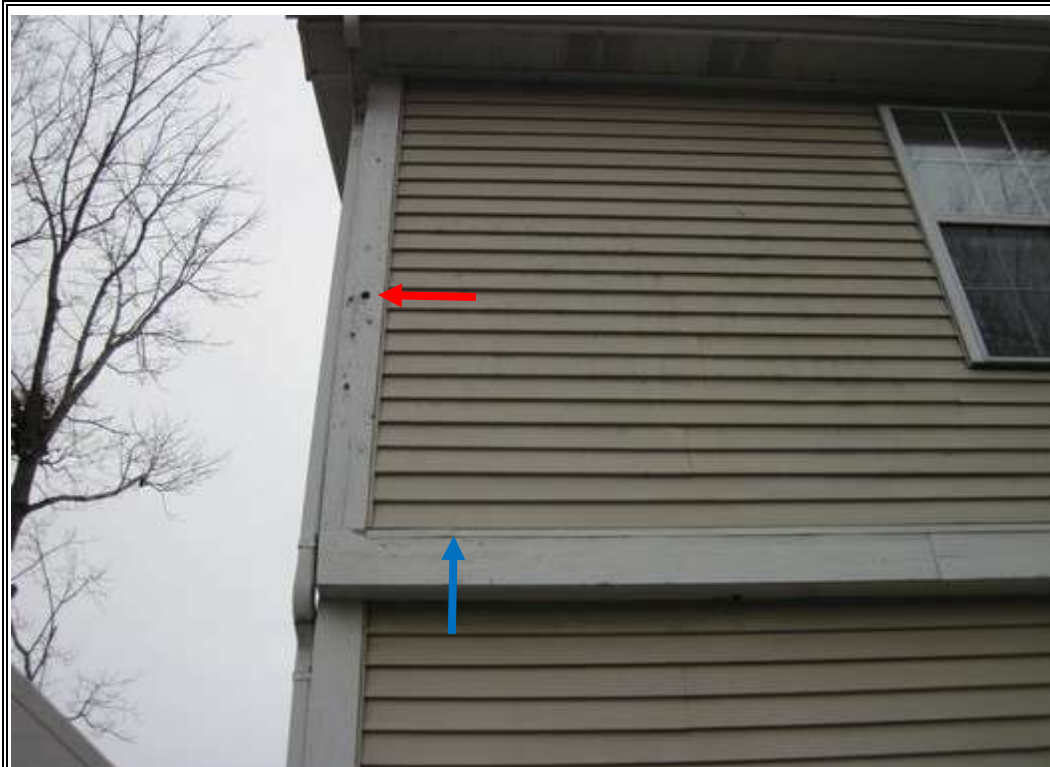
**Photo Number**  
**38**

Holes in trim board where knot apparently fell out. These holes should be repaired to keep pest and rain out. Blue arrow points to improper flashing installation—flashing should overlap several inches.

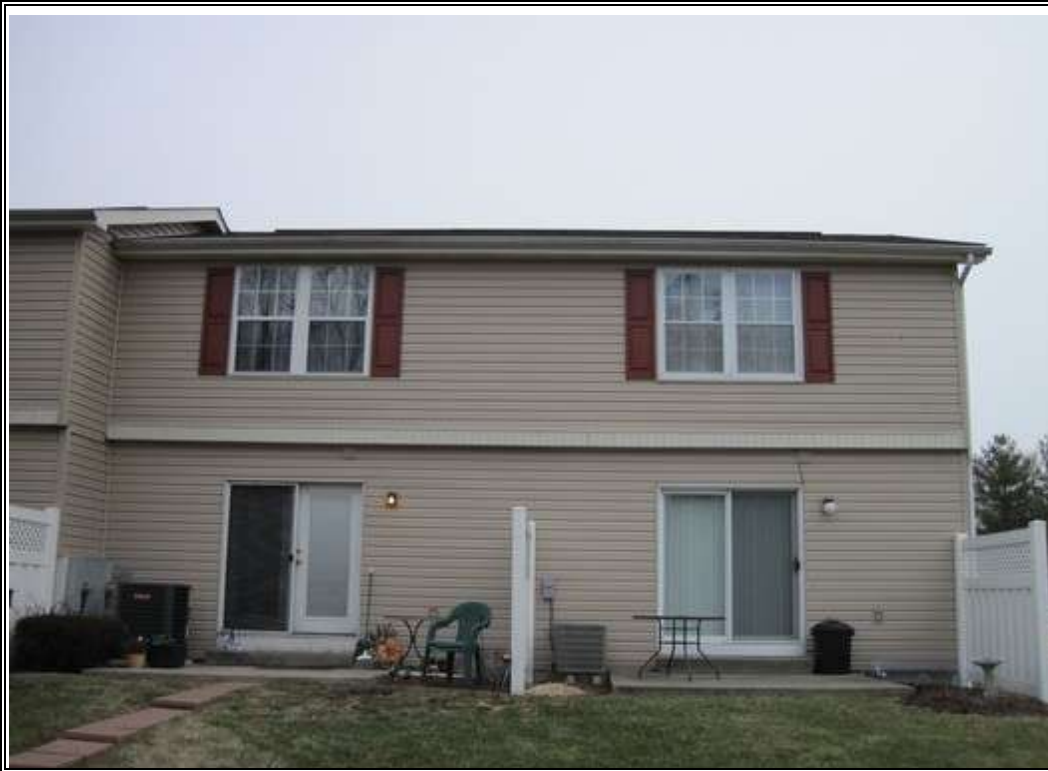
**Photo Number**  
**39**

Vertical siding installed in place of wood trim board. This siding should be specifically designed for vertical installation to prevent water getting behind the siding.

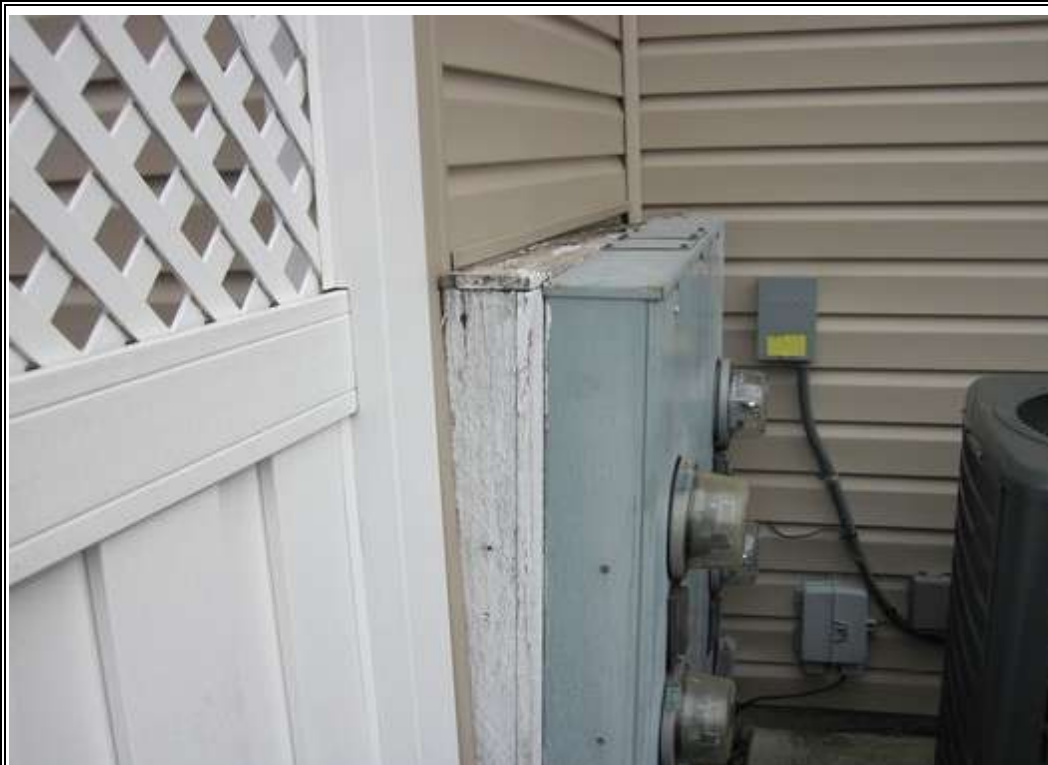
**Photo Number**  
**40**

Degrading electrical panel mounting board, which needs replacing.

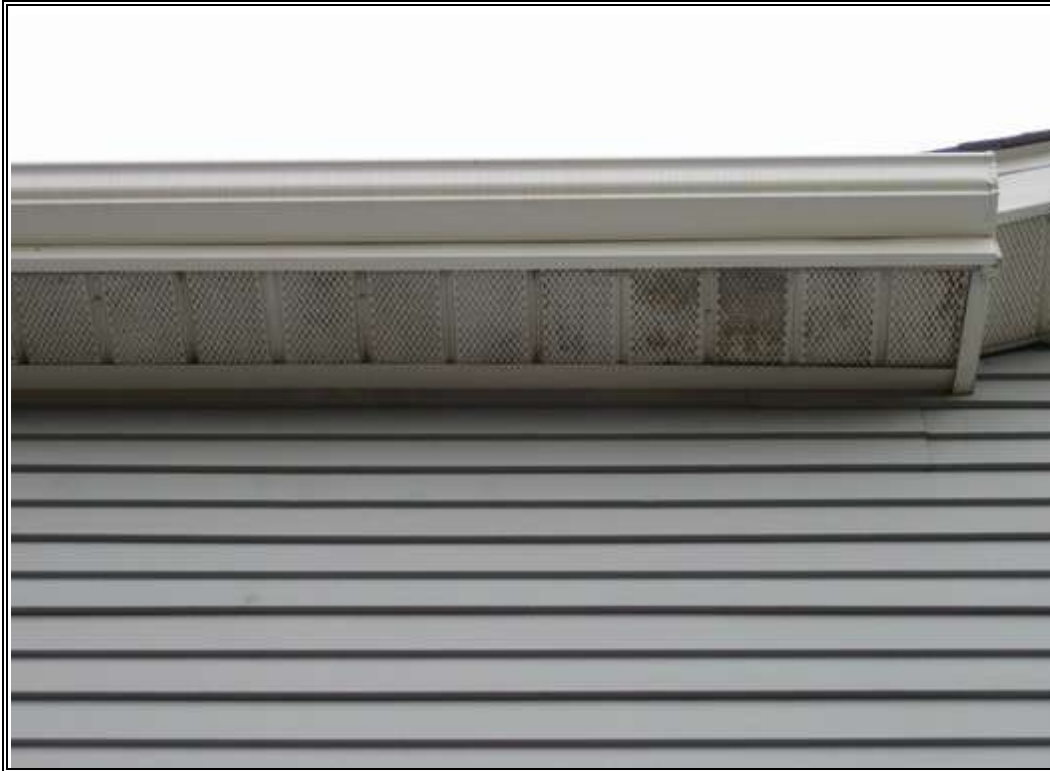
**Photo Number**  
**41**

Water stains on eave trim due to an unknown cause. These stains were found on a number of buildings and should be investigated.

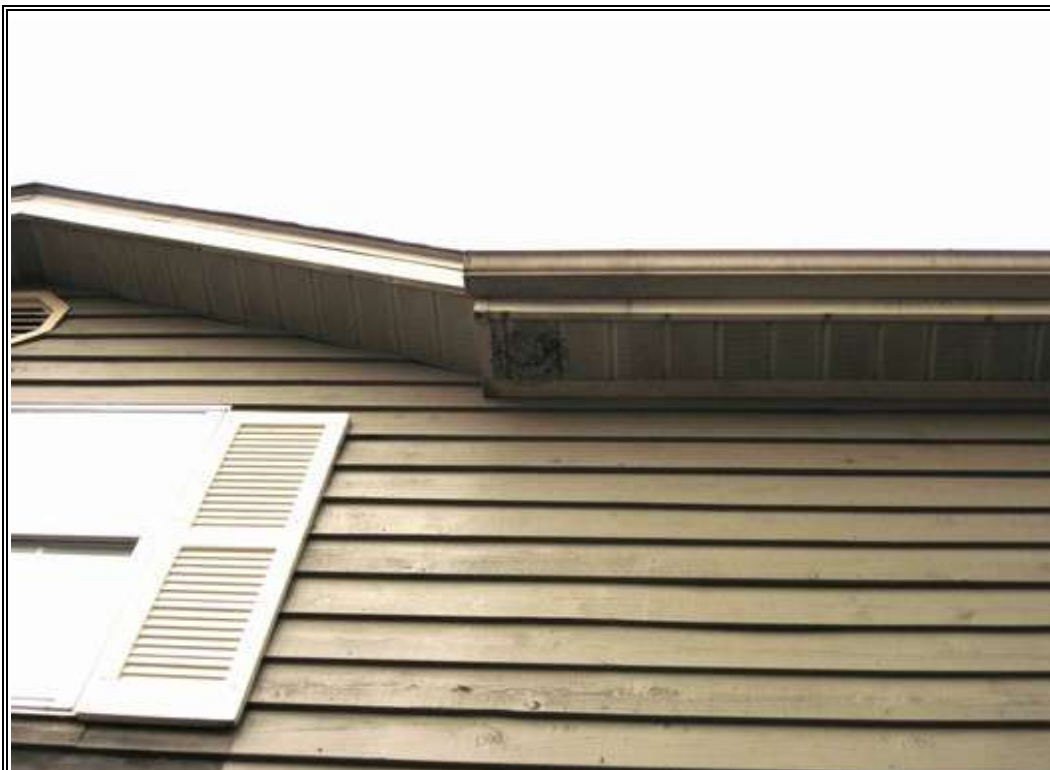
**Photo Number**  
**42**

Water stains on another eave trim. In this case, the gutter next to the area had water stains indicative of chronic overflow problems, although that problem might not be related to the eave trim stains.
