Full Reserve Study

University Woods Condominium Owners' Association, Inc.

Fairborn, Ohio

March 30, 2015

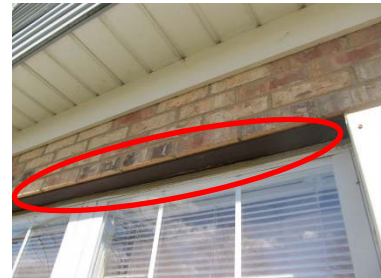
The metal lintels that support the brick over window and door openings are rusted. Rust causes expansion of the metal and damage to the brick. Association should remove the rust, apply a primer and paint the metal lintels in the near term, and fund this expense through the operating budget.

Rust at metal lintel

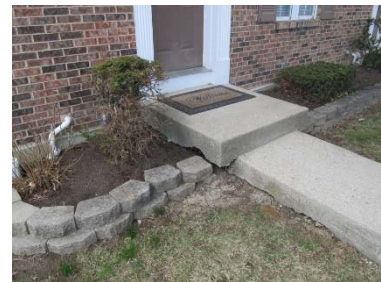
We observed undermining of stoops and sidewalks throughout the property. Remediation of this condition requires pumping grout under the concrete to provide support to the stoops and sidewalks.

Undermined stoop at 2153 Chapel

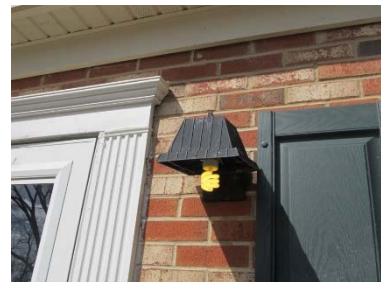
We note light fixtures that operate during the daylight. Homeowners should replace the fixtures with daylight sensors for automated shut off during the day to minimize unnecessary energy usage.

Light operating during daylight

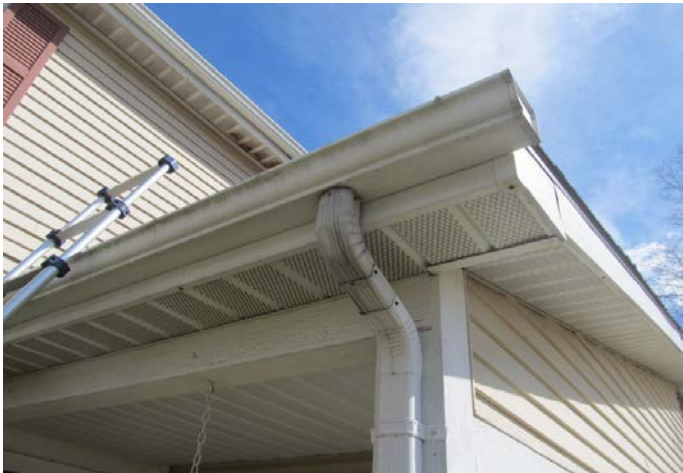
Material:	aluminum
Gutter profile:	five-inch seamless K-style
Downspout size:	two-inch by three-inch (adequate)
Overall condition:	fair
Specific condition:	dented sections, finish deterioration and rust at fasteners
Quantity (linear feet):	3,700
Per home (linear feet):	70
Cost (\$/linear foot):	\$8
Current total cost:	\$29,600
Cost per home:	\$580
Assumptions:	replace with .027-inch thick aluminum
Operating expenses:	semiannual inspections, repairs at seams and fastening points, cleaning and verification that the downspouts discharge away from foundations

aluminum gutter and downspout

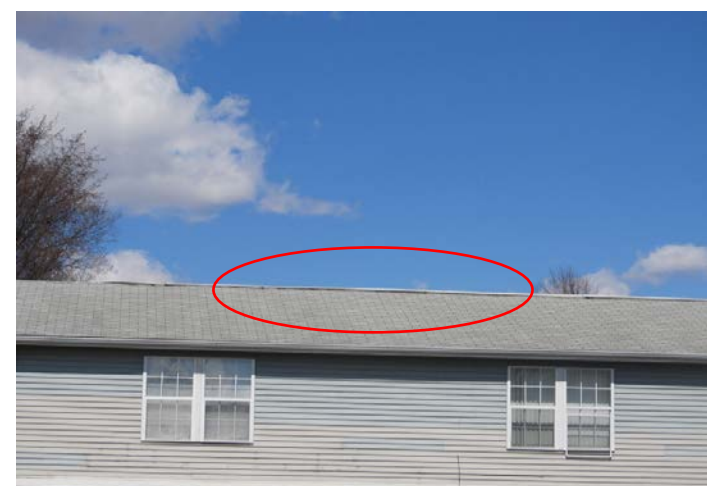
example of ridge vents improperly continuous between units

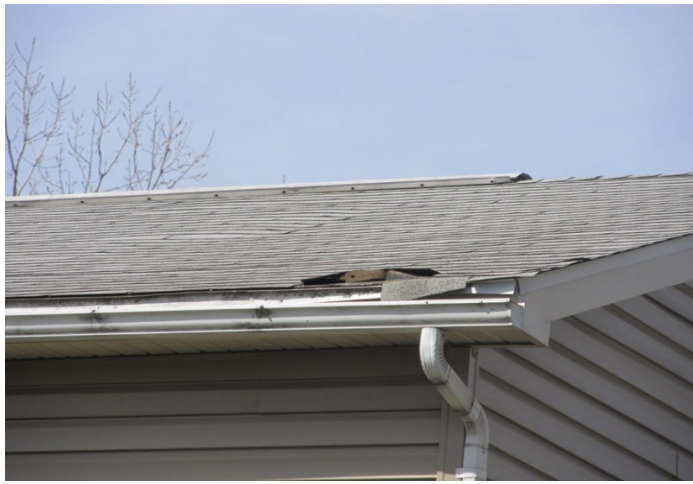
repairs necessary at 2113 Chapel

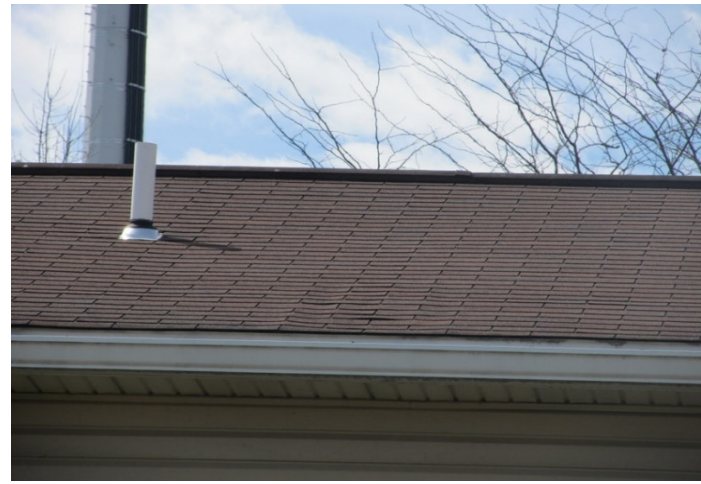
cupped shingles at 2089 Chapel

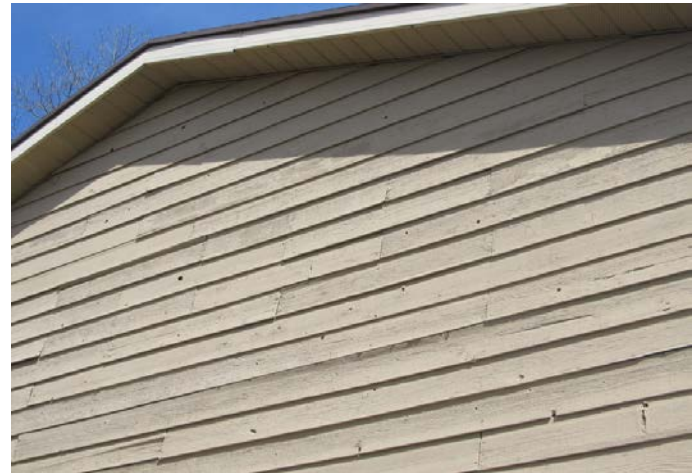
Material:	wood
Profile:	shiplap and plywood
Overall condition:	poor
Specific condition:	wood rot and curled siding
Locations:	410-412 White Ash 419-421 White Ash 427-429 White Ash
Quantity (square feet):	9,100
Cost (\$/square foot):	\$5.10
Current total cost:	\$46,400
Operating expenses:	cleaning, securing/replacement of loose pieces
Anticipated costs:	remove existing siding install building paper replacement with .042-inch thick vinyl siding replace soffit and fascia replace gable vents replace shutters

wood siding deterioration

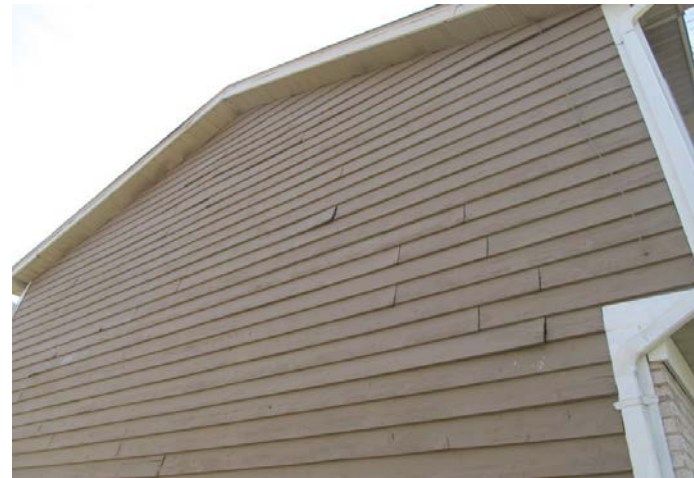
wood siding deterioration

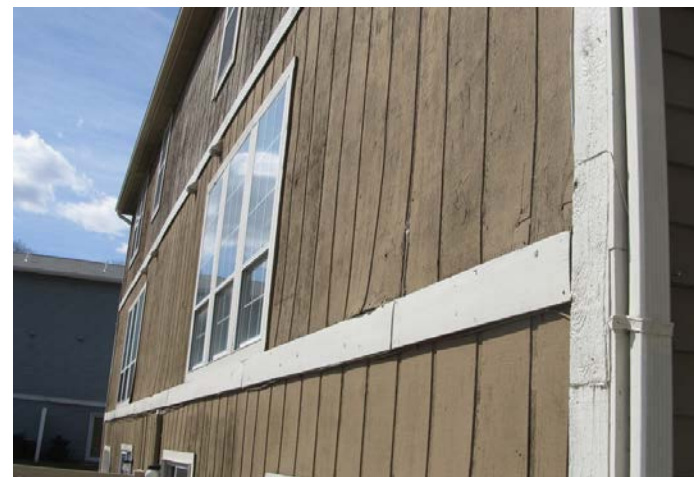
plywood siding deterioration

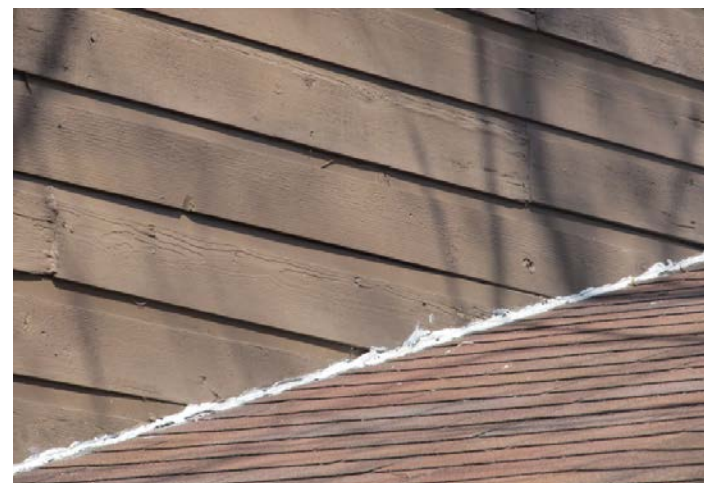
The siding throughout the property is in direct contact with the roof. This condition impedes drainage and makes replacement of the shingles more difficult. The Vinyl Siding Institute recommends a 1/2" gap at these locations. Vinyl siding installation should following the guidelines set by the Vinyl Siding Institute: <http://www.vinylsiding.org>

siding in contact with the roof (properly installed step flashing with the shingles and siding does not require caulk at this location)

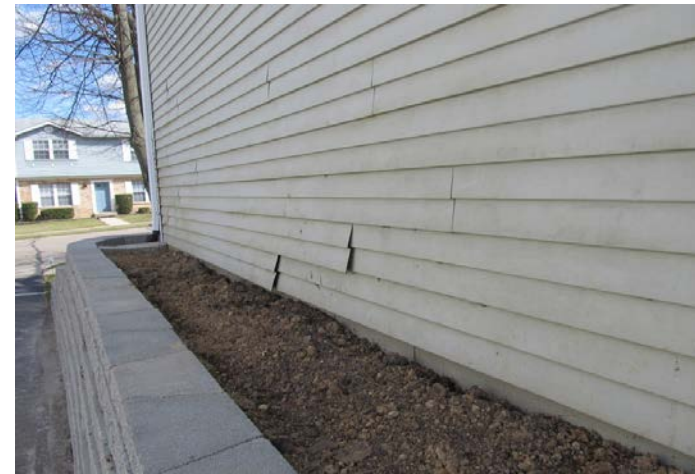
Material:	aluminum
Profile:	double clapboard
J channel (note 1):	exists at windows, doors and other penetrations
Overall condition:	poor
Specific condition:	damaged, loose and mismatched pieces
Locations:	2123-2127 Chapel 2131-2135 Chapel 2141-2145 Chapel 2149-2153 Chapel 2161-2167 Chapel 2173-2181 Chapel 2130-2132 Chapel 2148-2150 Chapel 2160-2162 Chapel 2172-2174 Chapel
Quantity (square feet):	28,300
Cost (\$/square foot):	\$5.10
Current total cost:	\$144,300
Operating expenses:	cleaning, securing/replacement of loose pieces
Anticipated costs:	remove existing siding install building paper replacement with .042-inch thick vinyl siding replace soffit and fascia replace gable vents replace shutters

loose aluminum siding

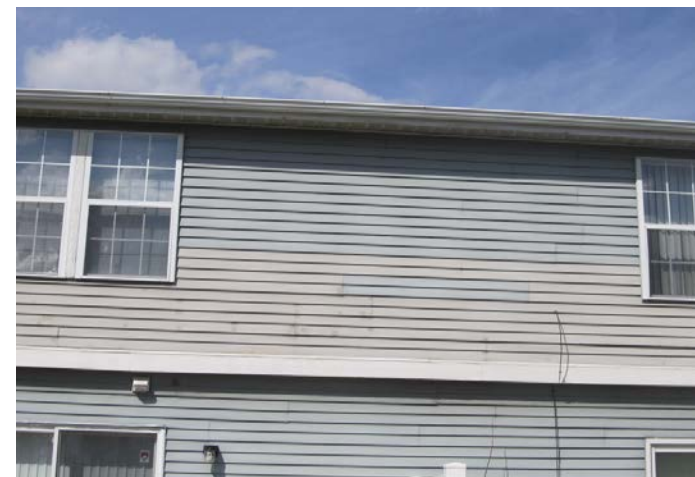
mismatched aluminum siding

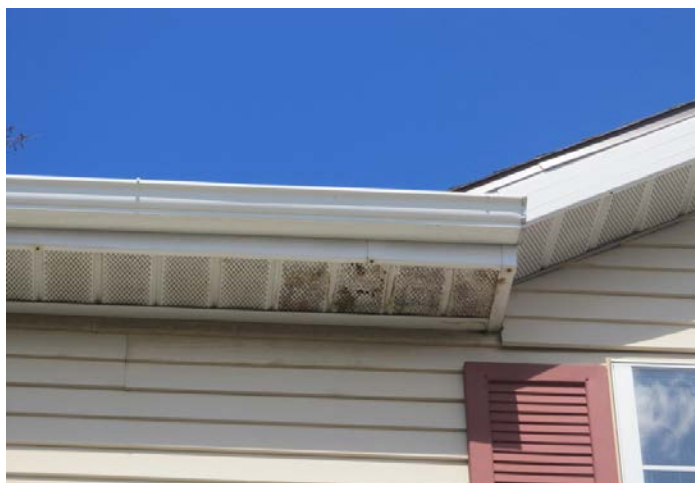
soffit deterioration at 2127 Chapel

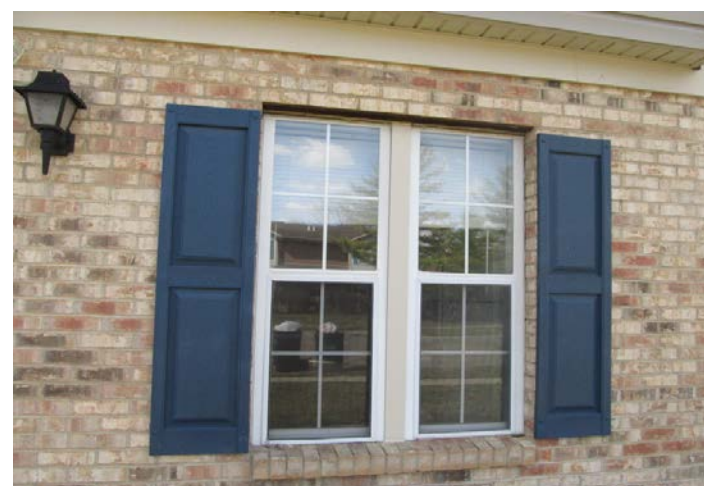
A portion of the shutters have four fasteners per panel while others have six. We recommend six fasteners at all shutter panels.

shutters with 4 fasteners per panel at 2101

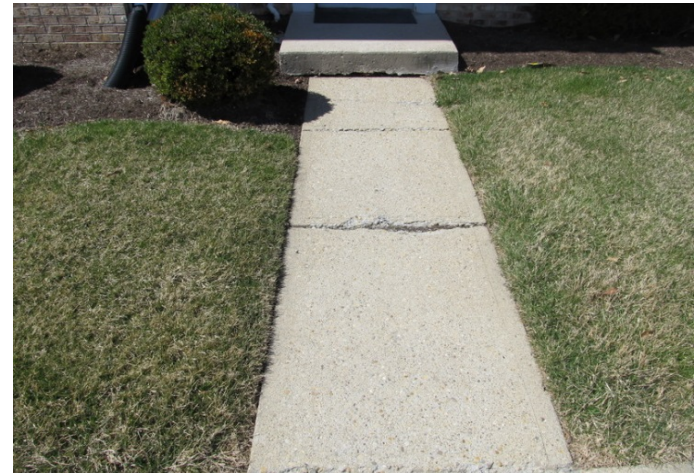
sidewalk deterioration at 2897 Chapel

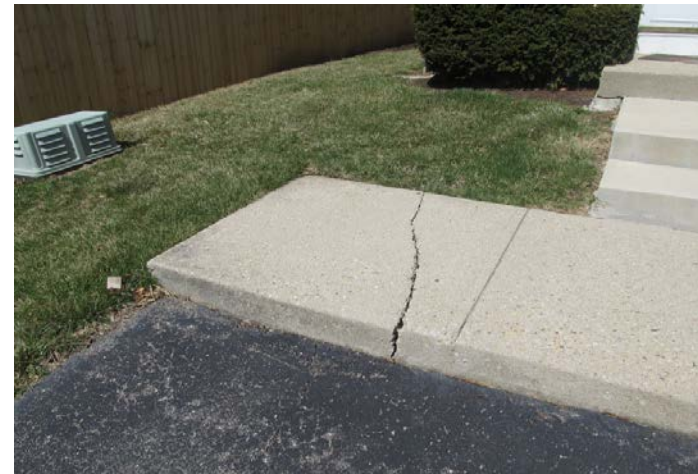
cracked sidewalk section at 2127 Chapel

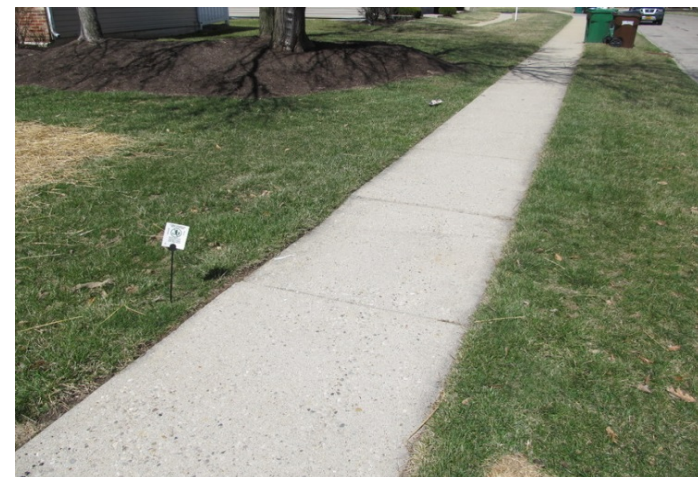
settled sidewalk section at 2105 Chapel

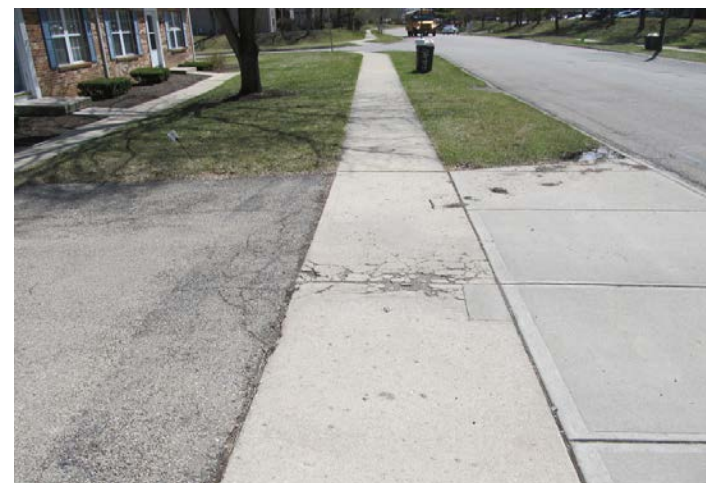
sidewalk deterioration at 2172 Chapel

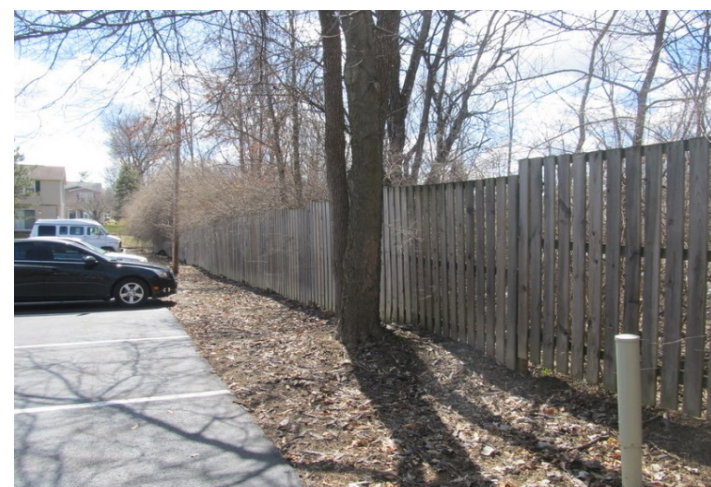
dated northern length of fence

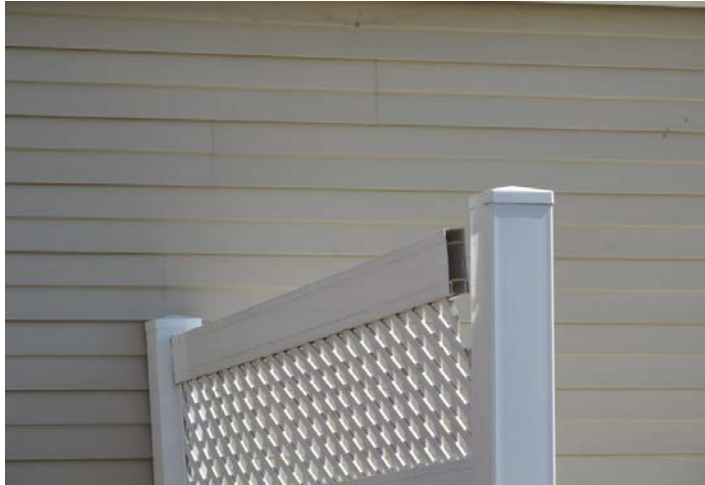
loose horizontal rail at 2141-2145 Chapel

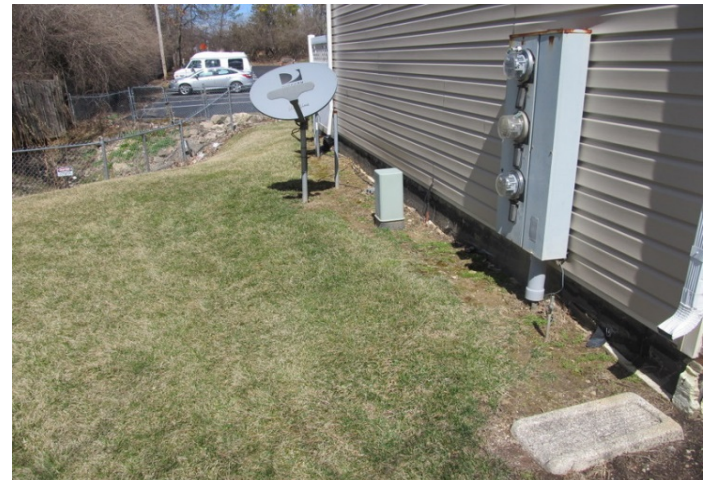
The grade behind 2109 Chapel has settled and eroded towards the stream to the west. This is noted by increased foundation and electrical conduit exposure, and slight erosion of the sod. The minor crack in the basement wall may be attributed to this condition as well. Remediation will require stabilization of the grade adjacent to the stream and backfilling the lost soil. The Association should contact the government agency responsible for the stream (likely the Army Corps of Engineers) for possible remediation of this condition.

grade settlement and erosion towards stream at 2109 Chapel

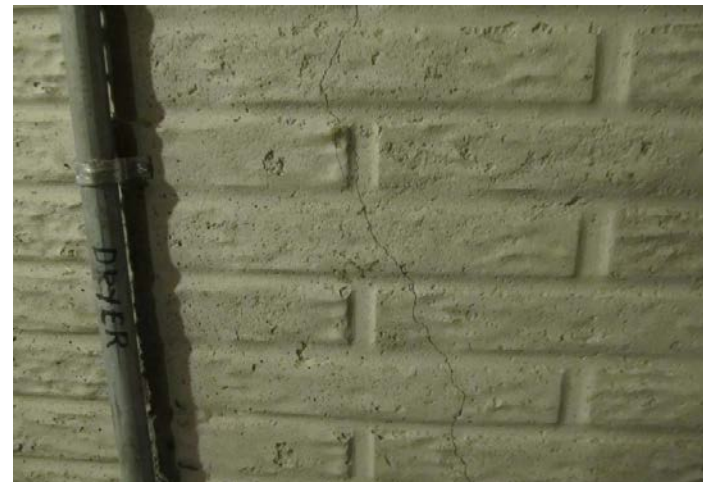
minor crack in wall at 2109 Chapel - stabilize grade and monitor for continued movement

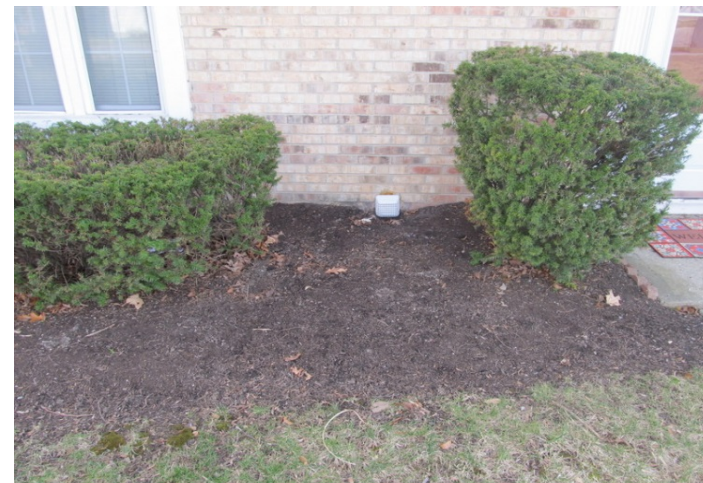
Units 2161-2167 Chapel report water seepage into their units. We note inadequate grading away from the building perimeter to promote drainage. We also note grading that is too high up on the building, resulting in blocked vents and siding in contact with landscape. We recommend a slight swale approximately 10 feet around the perimeter of the building to promote drainage. We recommend a slope of approximately two percent towards the swale. Drain tile connected to French drains in the swale would allow water to percolate into the ground.

landscape graded around vent at 2161-2167 Chapel

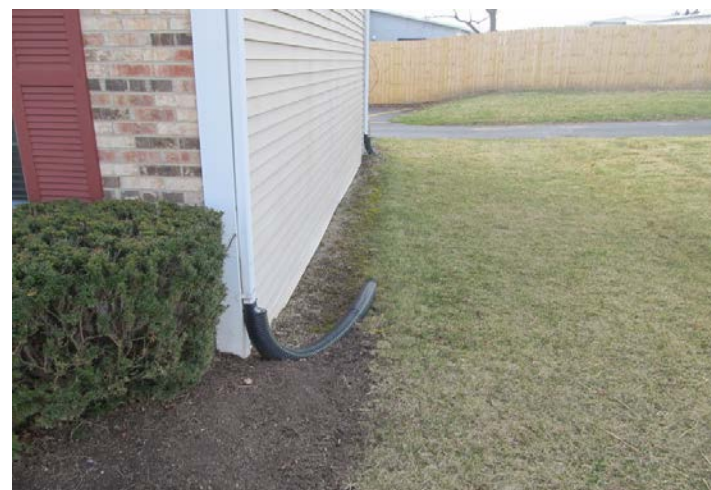
lack of grading away from building at 2161-2167 Chapel

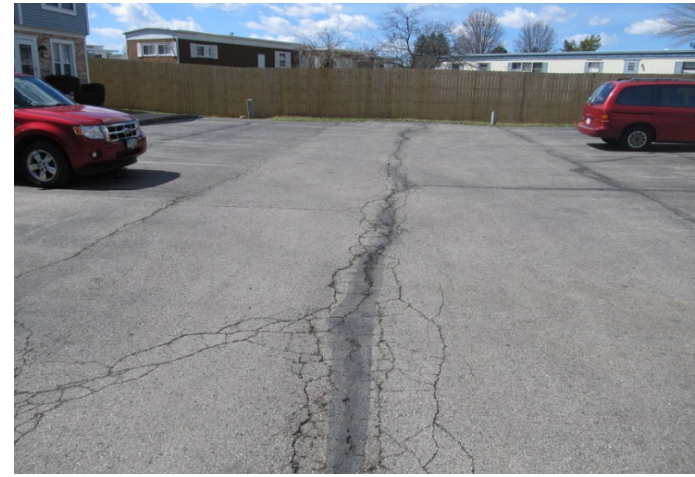
pavement requiring repairs

Crack repair all joints and patch potholes in the pavement to prevent water infiltration. This will minimize deterioration to the pavement and underlying base.

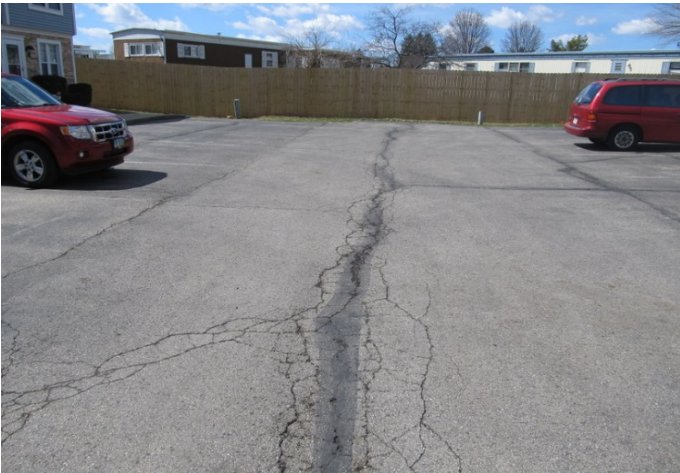
pavement in fair condition at 2123-2135 Chapel

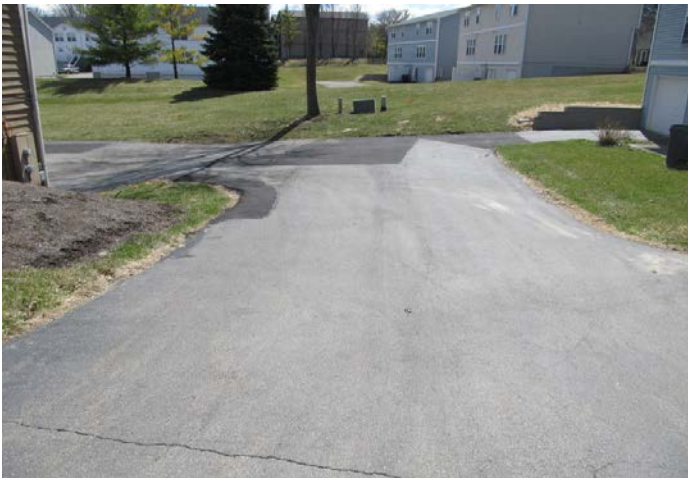
pavement in fair condition at 410-412 White Ash and 2148-2150 Chapel

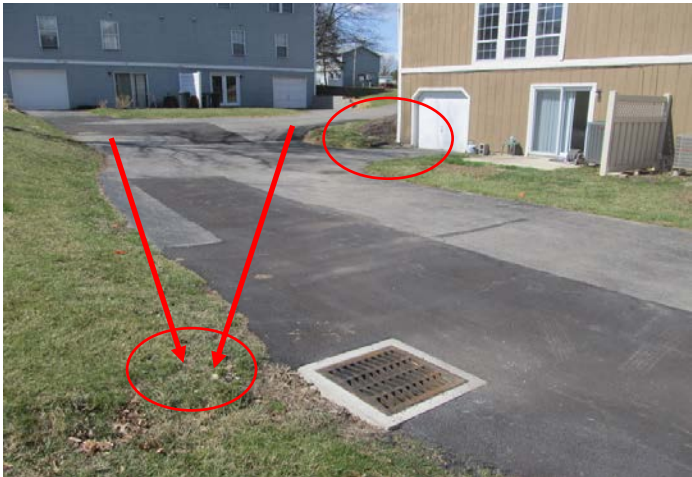
The catch basin at 410-412 White Ash is inadequate for drainage of the pavement resulting in flooding of the adjacent garage. The exit drain pipe in the catch basin is atypically high in the basin resulting in minimal, if any, storage of water in the basin as it accumulates to exit. The Association should consider installation of a larger drain pipe to be done in conjunction with the replacement of the utility pipes in the adjacent berm by the utility company. The Association should also consider installation of a French drain in the pavement adjacent to the garage that floods and additional French drains in the landscape area. Regrading of the pavement and installation of slight asphalt curbs at the time of repaving should direct storm water to the proposed drains in the landscape area.

catch basin at 410-412 White Ash is inadequate for drainage of pavement resulting in flooding of the adjacent garage - regrade pavement and install French drains

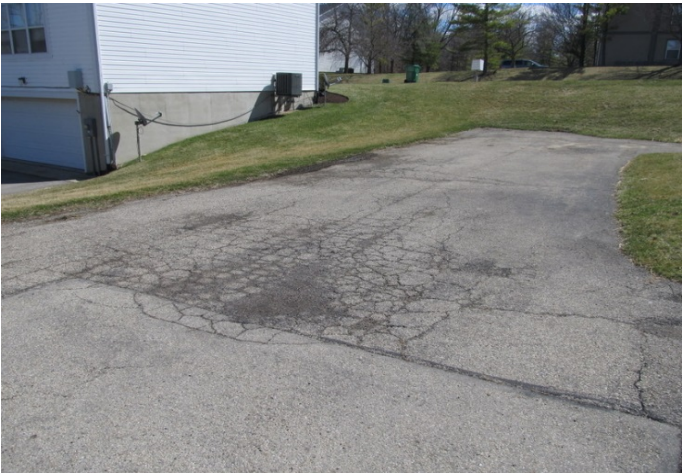
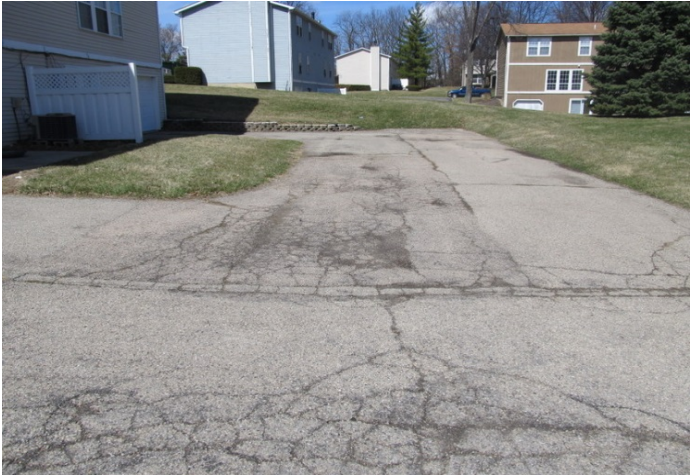
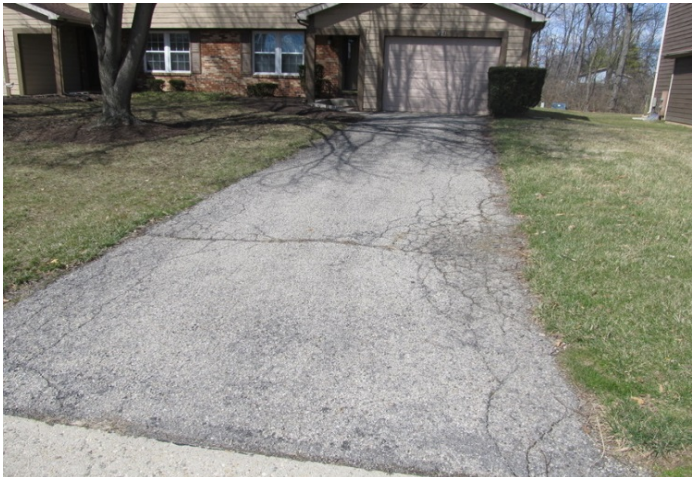
Material:	asphalt
Overall condition:	poor
Specific condition:	cracks and settlement
Locations:	2160-2174 Chapel 411-429 White Ash
Quantity (square yards):	890
Repaving method:	total replacement
Cost (\$/square yard):	\$20
Current total cost:	\$17,440
Anticipated costs:	remove pavement, regrade & augment base install 3" of new pavement

pavement in poor condition

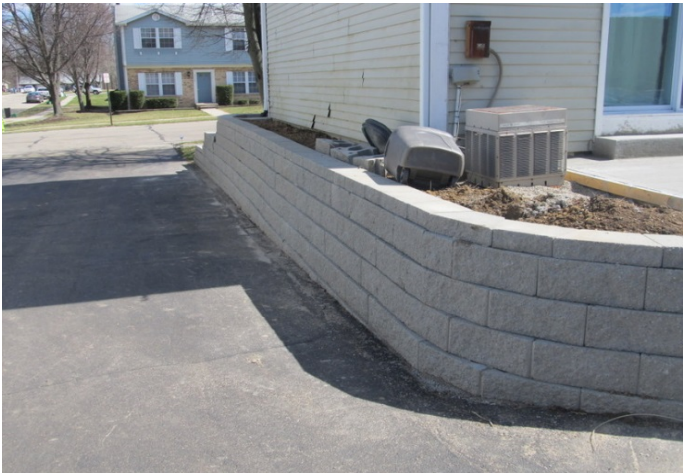
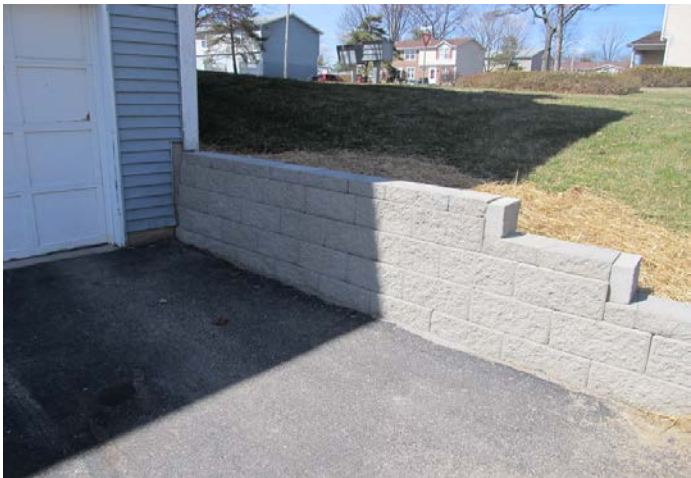
The recently replaced masonry retaining walls do not include drainage systems to relieve hydrostatic pressure from behind the walls. Since these walls are relatively short and are not retaining much soil, we suspect that this will not be an issue. However, the Association should monitor the walls for

movement and water stains. Renovating the walls to include a drainage system will be necessary if these conditions appear.

recently replaced masonry retaining wall

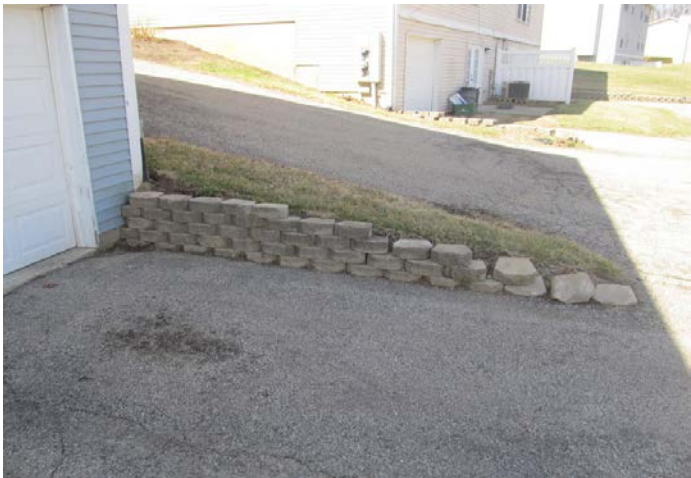
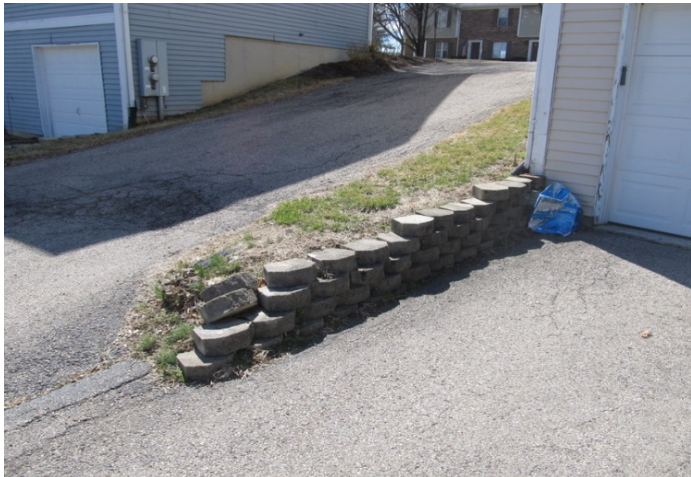
Material:	masonry and wood
Drainage system:	does not exist to relieve hydrostatic pressure
Overall condition:	fair to poor
Specific condition:	wall failure
Locations:	throughout property
Number of walls (each):	7
Quantity (square feet):	300
Per home (square feet):	10
Cost (\$/square foot):	\$16
Current total cost:	\$4,900
Cost per home:	\$96
Operating expenses:	resetting of top course if they become loose

dated and failing retaining wall
