Full Reserve Study

University Woods Condominium Owners' Association, Inc.

Fairborn, Ohio

March 30, 2015

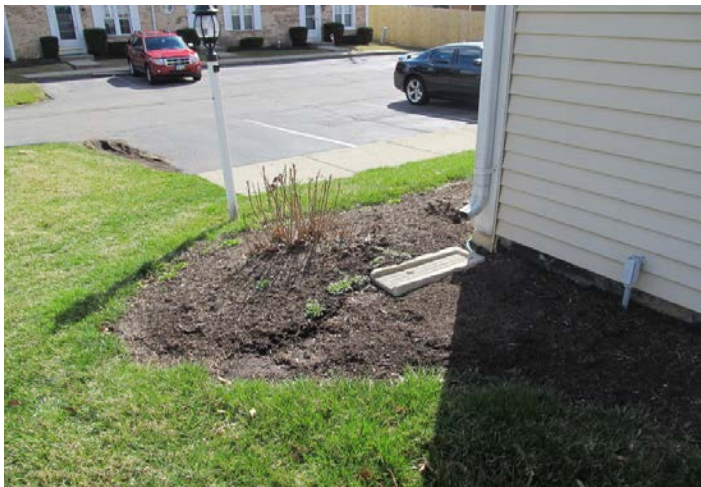
The downspouts discharge too high off the ground. This condition results in excessive splashing, soil compaction and erosion. In addition, the downspouts discharging at the foundations increase the potential for water infiltration into the unit basements. We recommend the installation of subterranean downspout extensions that discharge 10 feet away from the buildings through pop-up drainage emitters in the landscape areas. The Association should consider this improvement at the time of gutter and downspout replacement, but earlier in problematic areas.

downspout too high off ground causing excessive splashing and erosion

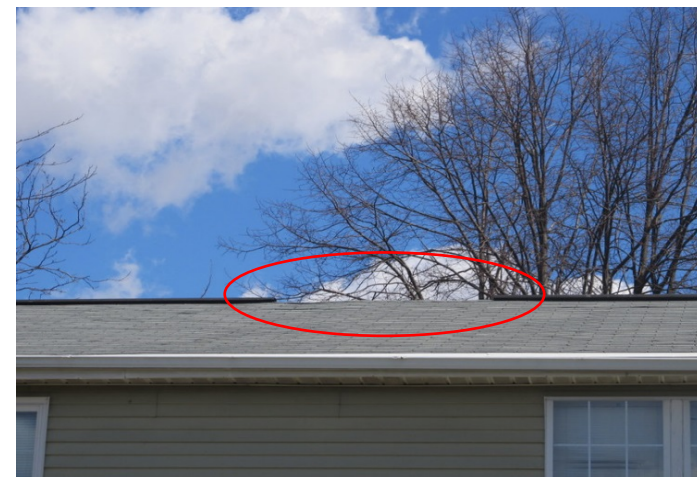
example of ridge vents properly not continuous between units

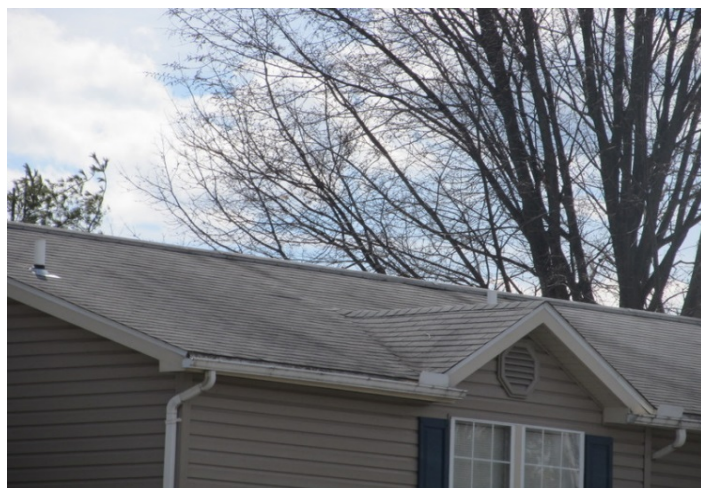
curled and weathered shingles at 2113-2117 Chapel

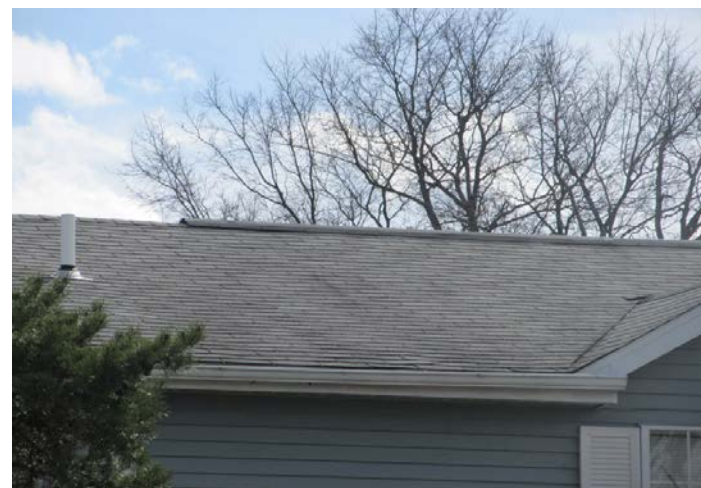
weathered shingles at 2131-2135 Chapel

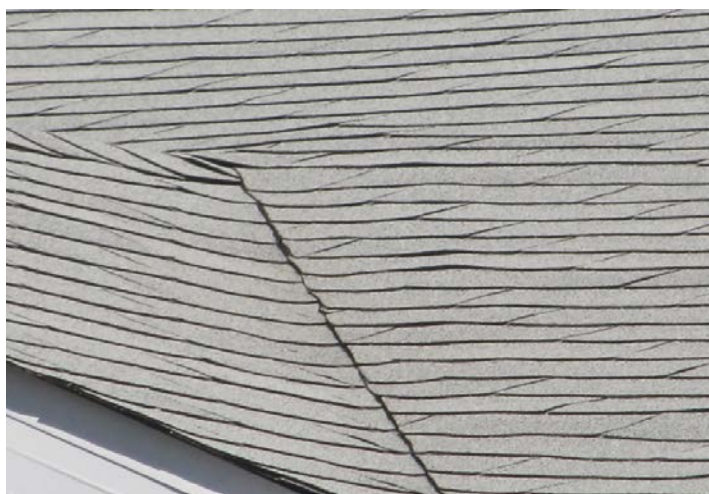
half weaved valley

For roof replacement: 1) Use self-adhering underlayment at roof gutter edges and valleys. 2) Use metal W valley flashing (rather than weaved shingles) to maximize the useful life of shingles in valleys. 3) Use lead flashing at waste pipes to minimize future maintenance costs. 4) Install metal drip edge around the entire perimeter of roofs. The drip edge discharges storm water away from the buildings and helps secure the fascia.

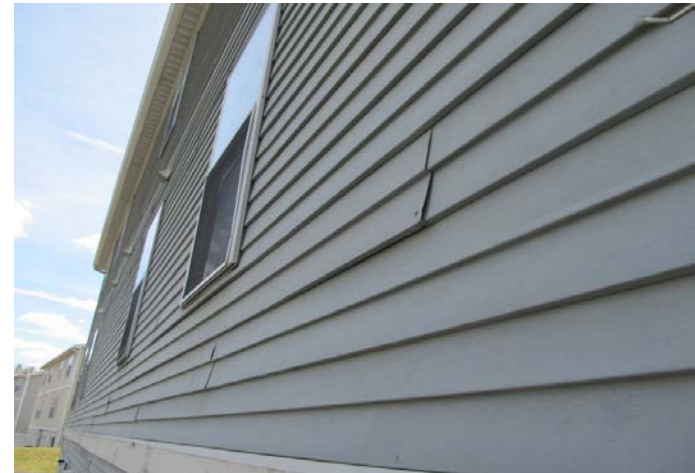
Material:	aluminum
Profile:	double clapboard
J channel (note 1):	exists at windows, doors and other penetrations
Overall condition:	poor
Specific condition:	damaged, loose and mismatched pieces
Locations:	2123-2127 Chapel 2131-2135 Chapel 2141-2145 Chapel 2149-2153 Chapel 2161-2167 Chapel 2173-2181 Chapel 2130-2132 Chapel 2148-2150 Chapel 2160-2162 Chapel 2172-2174 Chapel
Quantity (square feet):	28,300
Cost (\$/square foot):	\$5.10
Current total cost:	\$144,300
Operating expenses:	cleaning, securing/replacement of loose pieces
Anticipated costs:	remove existing siding install building paper replacement with .042-inch thick vinyl siding replace soffit and fascia replace gable vents replace shutters

aluminum siding with double clapboard profile

Anticipated costs: remove existing siding
install building paper
replacement with .042-inch thick vinyl siding
replace soffit and fascia
replace gable vents
replace shutters

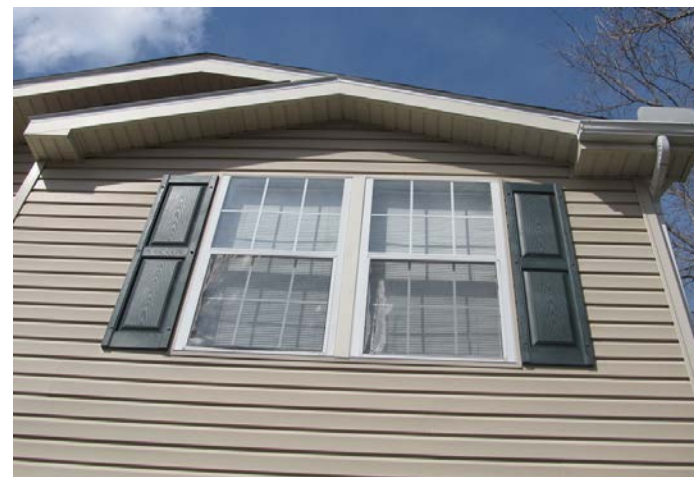
vinyl shutters with 6 fasteners per panel

A portion of the shutters have four fasteners per panel while others have six. We recommend six fasteners at all shutter panels.

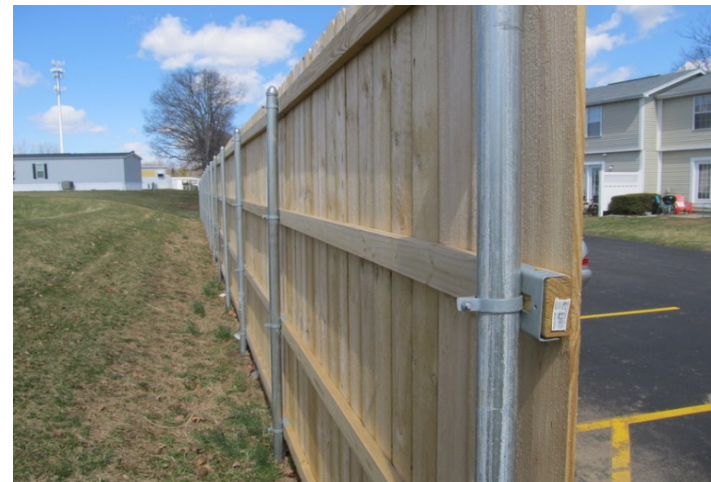
The recently replaced fence appears well built with steel posts and ideally without toe-nailed connections.

steel posts

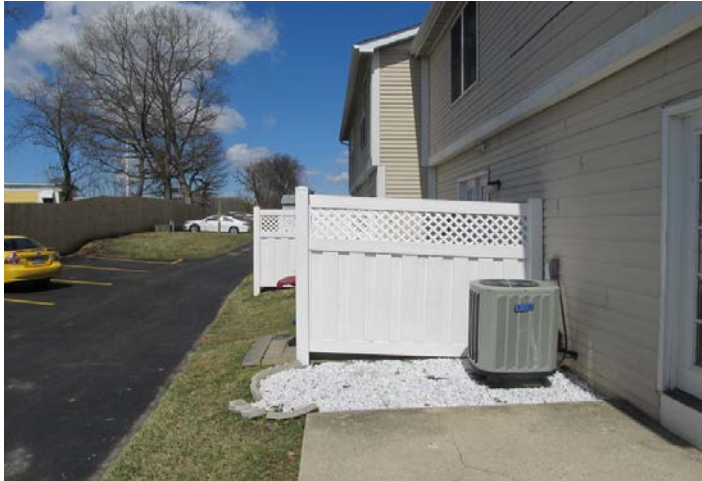
Fences - Vinyl	
Material:	vinyl
Locations:	rear patios
Fence profile:	board on board with upper lattice
Post type:	hollow vinyl frame
Overall condition:	fair
Specific condition:	skewed frames, warped sections and loose sections
Quantity (linear feet):	400
Per home (linear feet):	10
Cost (\$/linear foot):	\$30
Current total cost:	\$12,000
Cost per home:	\$235

skewed frame

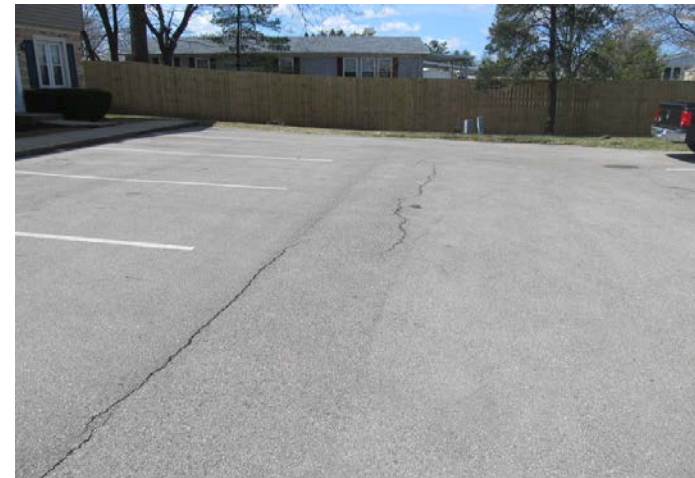
newer pavement without seal coat

aesthetic reasons, avoid the use of coal tar based pavement seal coats as they pollute waterways. Instead, consider a slurry coat of asphaltic emulsion to provide a sacrificial wearing surface to the pavement.

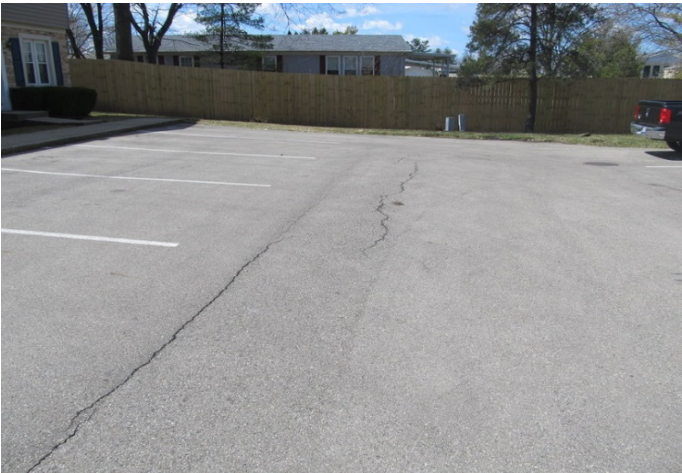
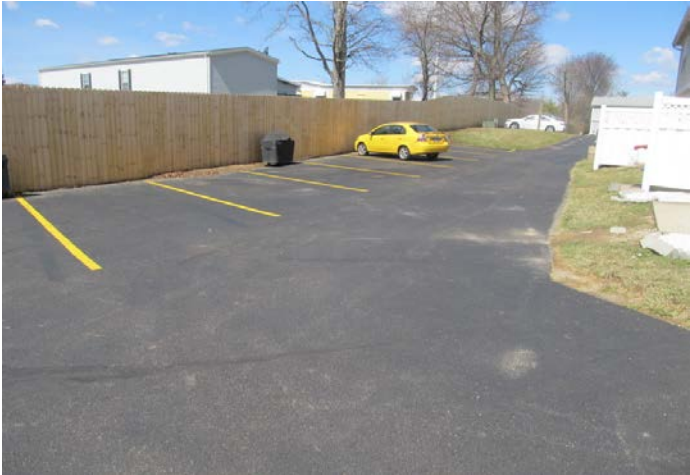
Material:	asphalt
Overall condition:	good
Specific condition:	no visible deterioration
Locations:	2085-2095 Chapel 2105-2117 Chapel 2141-2149 Chapel 2161-2181 Chapel
Quantity (square yards):	3,000
Repaving method:	total replacement
Cost (\$/square yard):	\$20
Current total cost:	\$60,000
Anticipated costs:	remove pavement, regrade & augment base install 3" of new pavement repairs to catch basins (1 each)

asphalt pavement in good condition

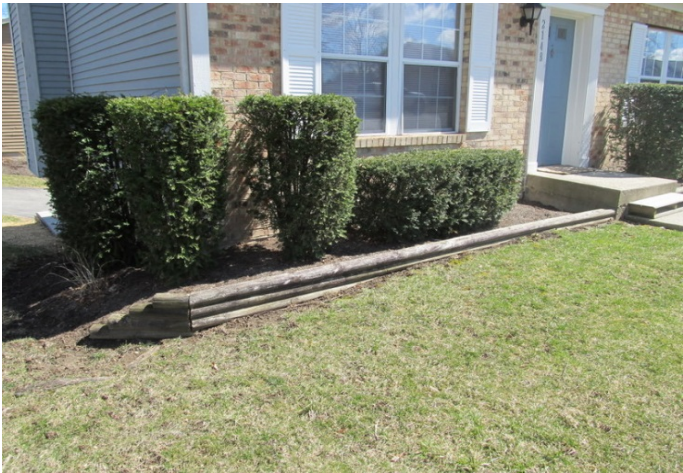
Material:	masonry and wood
Drainage system:	does not exist to relieve hydrostatic pressure
Overall condition:	fair to poor
Specific condition:	wall failure
Locations:	throughout property
Number of walls (each):	7
Quantity (square feet):	300
Per home (square feet):	10
Cost (\$/square foot):	\$16
Current total cost:	\$4,900
Cost per home:	\$96
Operating expenses:	resetting of top course if they become loose

wood retaining wall

The recently replaced masonry retaining walls do not include drainage systems to relieve hydrostatic pressure from behind the walls. Since these walls are relatively short and are not retaining much soil, we suspect that this will not be an issue. However, the Association should monitor the walls for

movement and water stains. Renovating the walls to include a drainage system will be necessary if these conditions appear.
